British Columbia's Mount Polley copper/gold/silver mine waste tailings disaster of August 4, 2014, located near the western-most reach of Quesnel Lake, is among the largest recorded disasters, by volume, in world history, with updated estimates of about 25 million cubic meters of toxic waters and heavy metal mine waste contaminants having escaped into the nearby environments of Hazeltine Creek and Quesnel Lake, destroying and inundating everything in its path, a most terrible and preventable tragedy.

This is the first investigative report on Mount Polley since the date of the disaster, 17 weeks previous, and provides an assessment and introductory history behind the inner workings of a terrible tragedy, of what appears to be an environmental crime. And, it is published during a time of interim darkness, as the BC government is temporarily withholding report and related information not already released concerning the planning and operations of the Mount Polley mine, perhaps until the early months of 2015 or later. That is when the reporting of one of a few separate investigations is scheduled for public release: a government-appointed three-panel member review committee (under narr

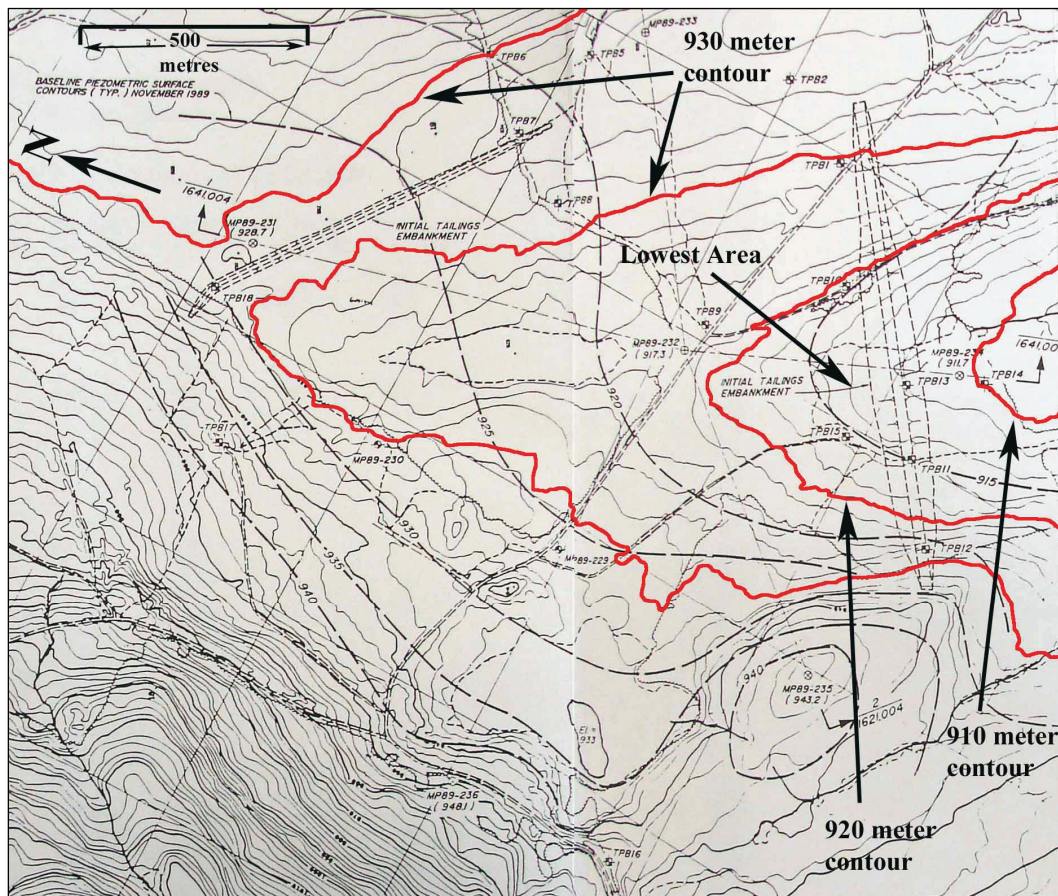
Left: Figure 4-9, Area B Test Pit and Borehole Plan, from Volume One of the 1990 Assessment report. The highlighted red lines show the original contour elevation locations of the Tailings Storage Facility. They show the flow regime of the Edney Tributary #1 watershed. The top left area between the “930 meter contour” areas is the divide for the location of the Perimeter Embankment, where the August 4, 2014 dam failure occurred.

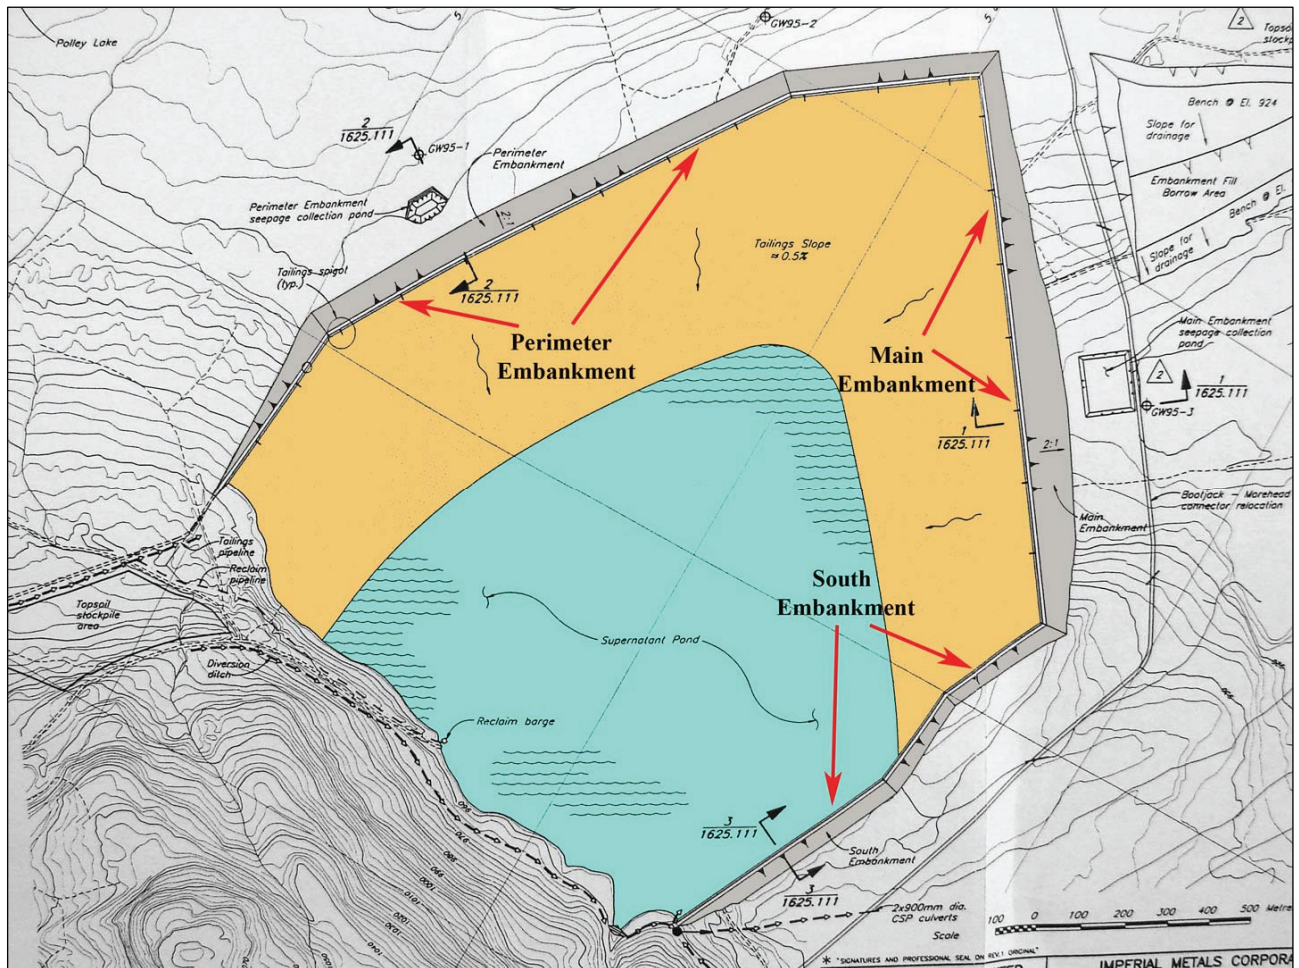
Above: The April 6, 1995 drawing, Figure 3.16, *Tailings Storage Facility Final Arrangement*, in the 1996 *Mount Polley Mine Reclamation Plan*, showing the final transition and supernatant locations concept of the TSF within the former natural contours of the headwaters of Edney Creek Tributary #1. The dark-gray shaded area denotes the outer downslope areas of the three embankments, the light-brown/tan shaded area is the sloped tailings slurry, and the greenish-blue area is the supernatant “pond,” situated directly on top of meters-deep saturated tailings mass.

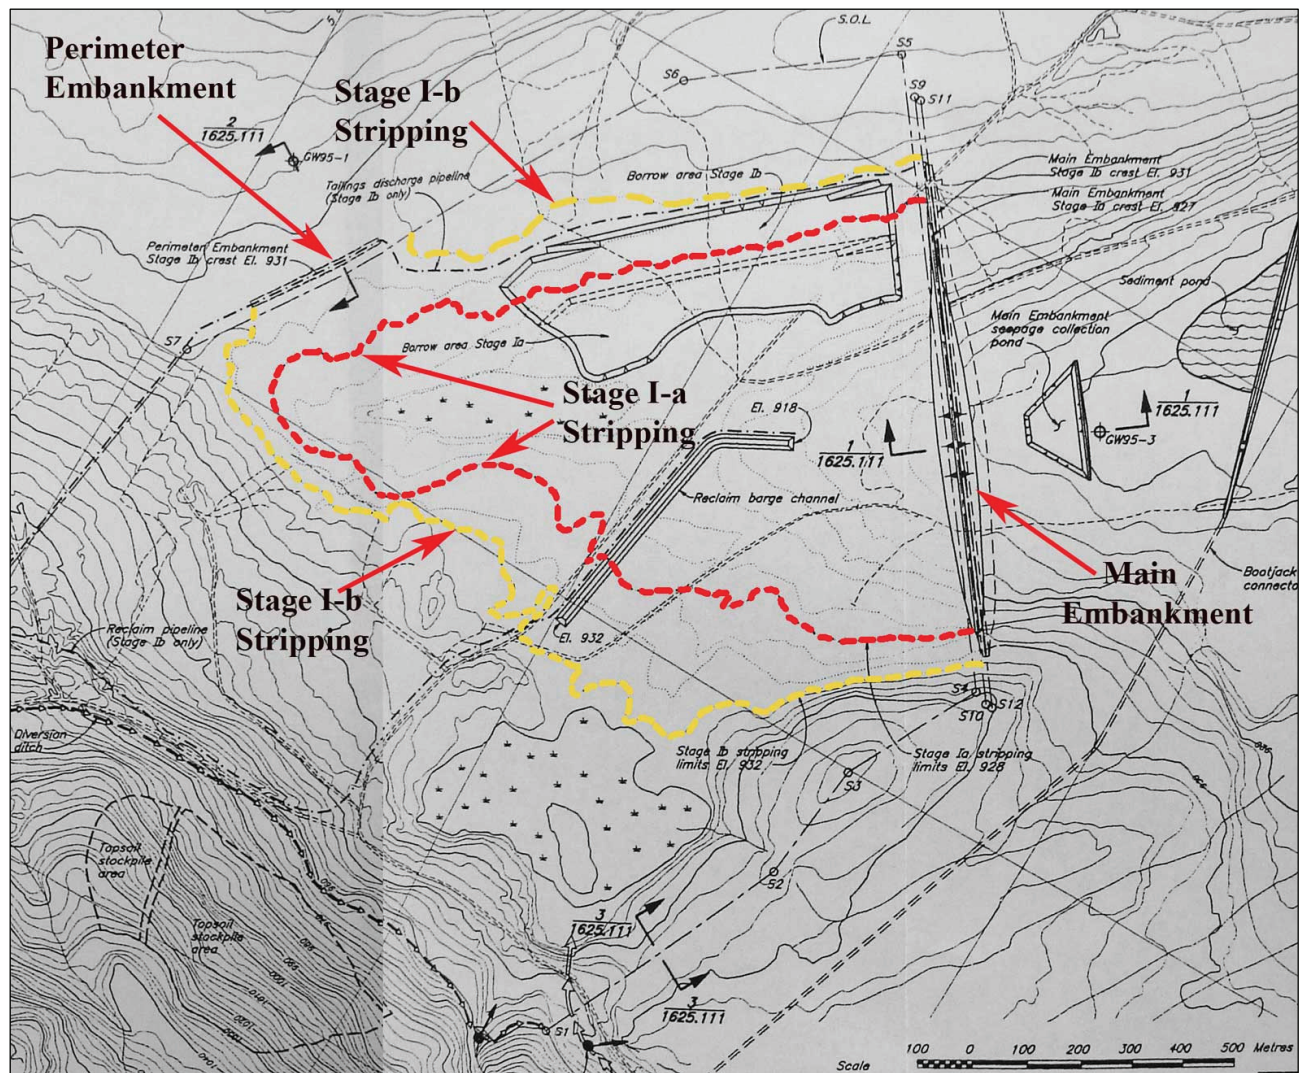
Above: Figure 3.15, *Stage Ia / Ib Tailings Impoundment General Arrangement*, in the 1996 Mount Polley Reclamation report. The red dotted line indicates elevation 928 meters, and the yellow dotted line indicates elevation 932 meters. Stage Ia embankment crest was set at 927 meters for the Main Embankment, and Stage Ib crest was set at 931 meters for the Main and Perimeter Embankments. The height of the Perimeter Embankment for Stage Ib was about one meter, and about 16 meters in height for the Main Embankment for Stage Ib, a difference of about 15 meters in elevation between the two embankments.

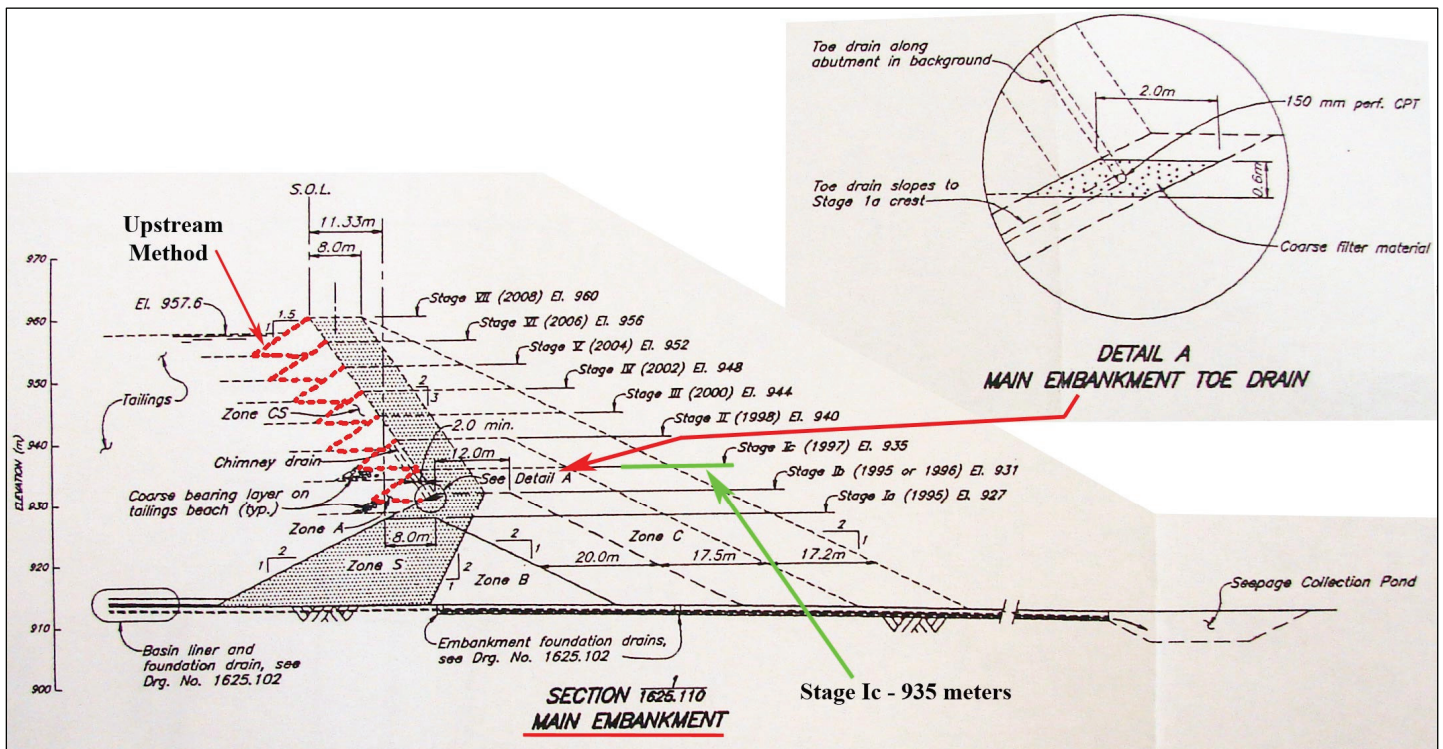
Above: Figure 3.18 from 1996 *Reclamation Plan* report. The red dotted lines show the Upstream Type method stages for the Main Embankment. Note the height in meters of Stage Ic elevation, and the large area below built up primarily of Centreline Type method, a much stronger foundation area than provided for the Perimeter Embankment foundation.

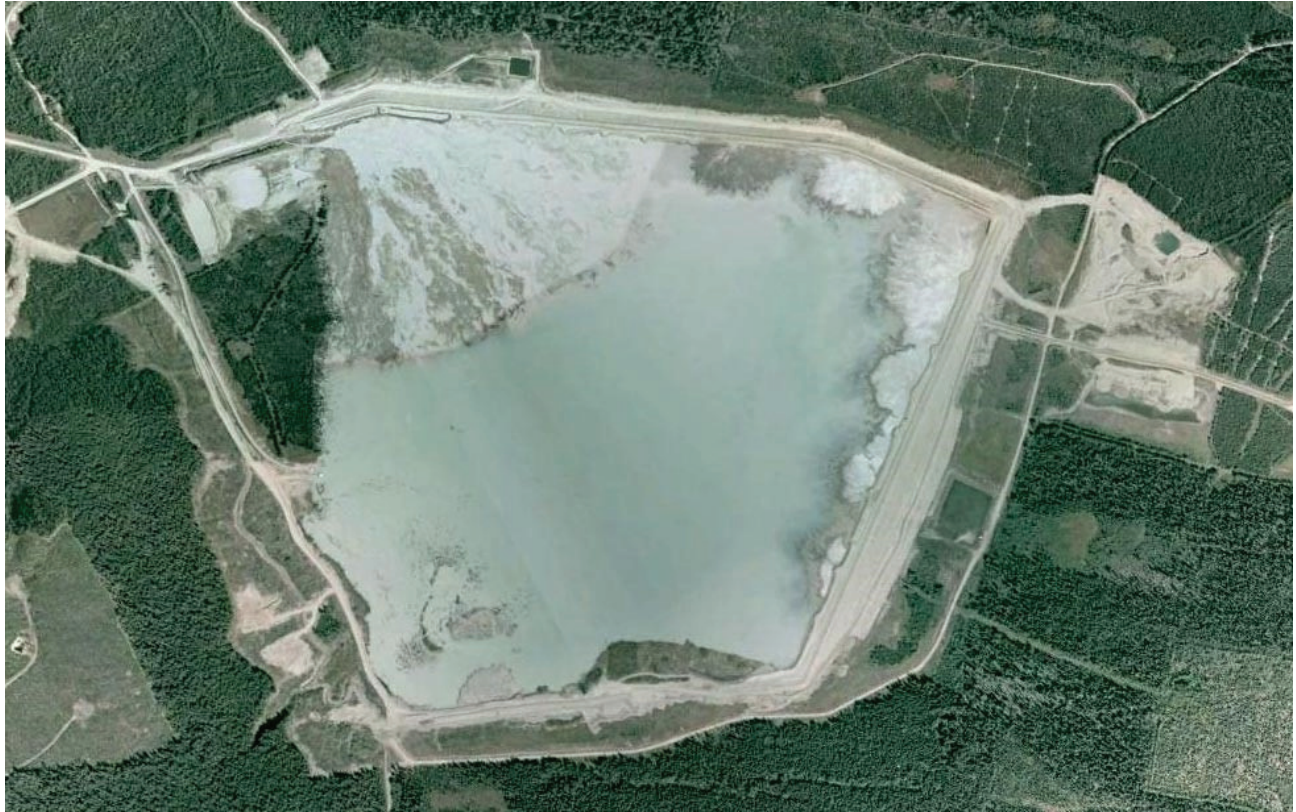
Above: 2004 Google-Earth photo of Mount Polley’s temporarily abandoned Tailings Storage Facility. The TSF was evidently left in this state for the “Care and Maintenance” period, where the mining company failed to properly and uniformly shape the tailings beaches around the TSF’s crest. The top area three-angled wall or embankment in the photo is the Perimeter Embankment, the straight wall to the right is the Main Embankment, and the bottom straight wall is the South Embankment. On the left there is no artificial wall, as the TSF impoundment used the natural slope contours as a functioning wall, expanding upslope, with landscape stripping as the impoundment was raised in stages over the years.

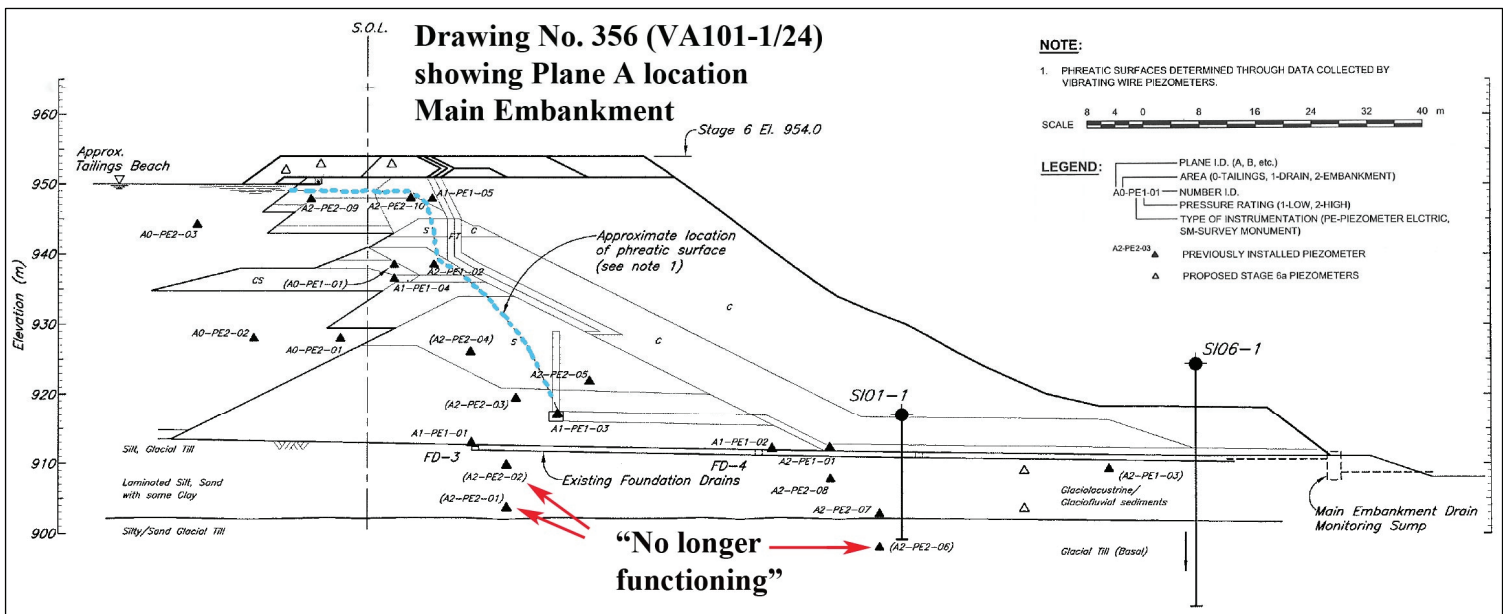
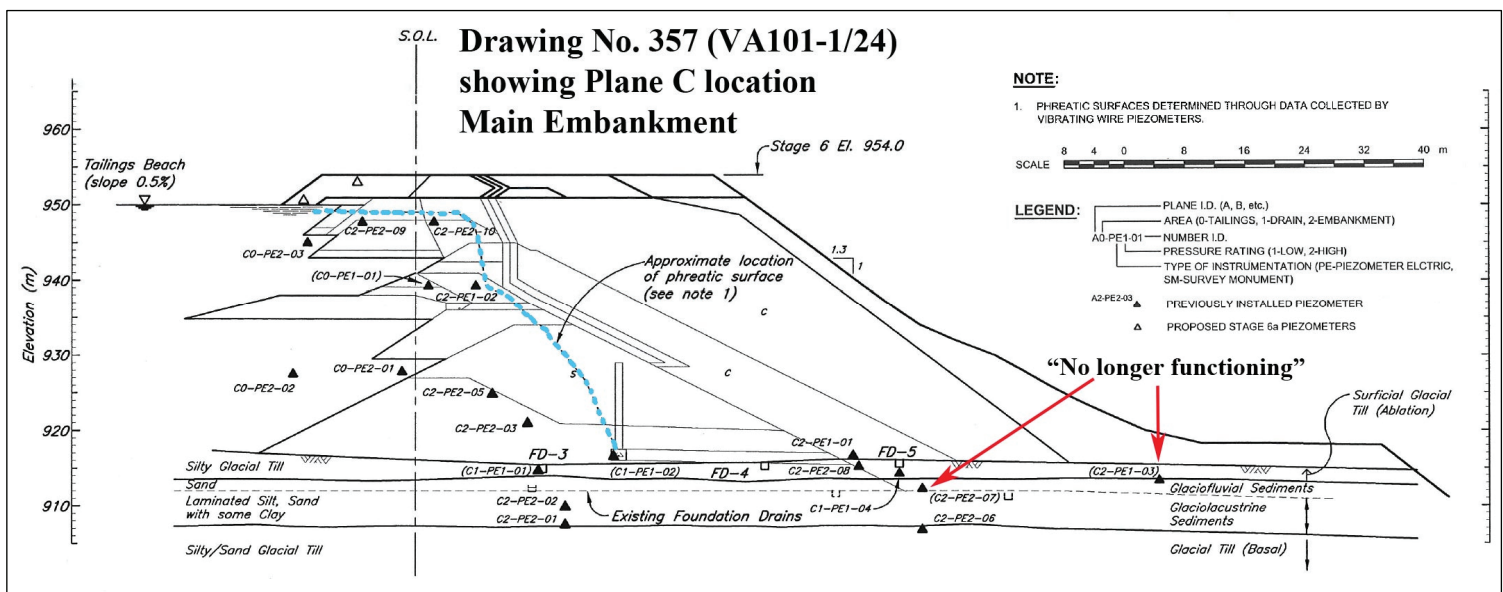
Above and Below: Two sections from drawings in the 2008 TSF inspection report showing Planes A and B piezometer locations within the Main Embankment. Here are shown 5 of the 32 “no longer functioning” piezometers as reported for 2008 in Table 4.1. Note the “approximate location” of the Phreatic (water table) surface line shown in blue dots.

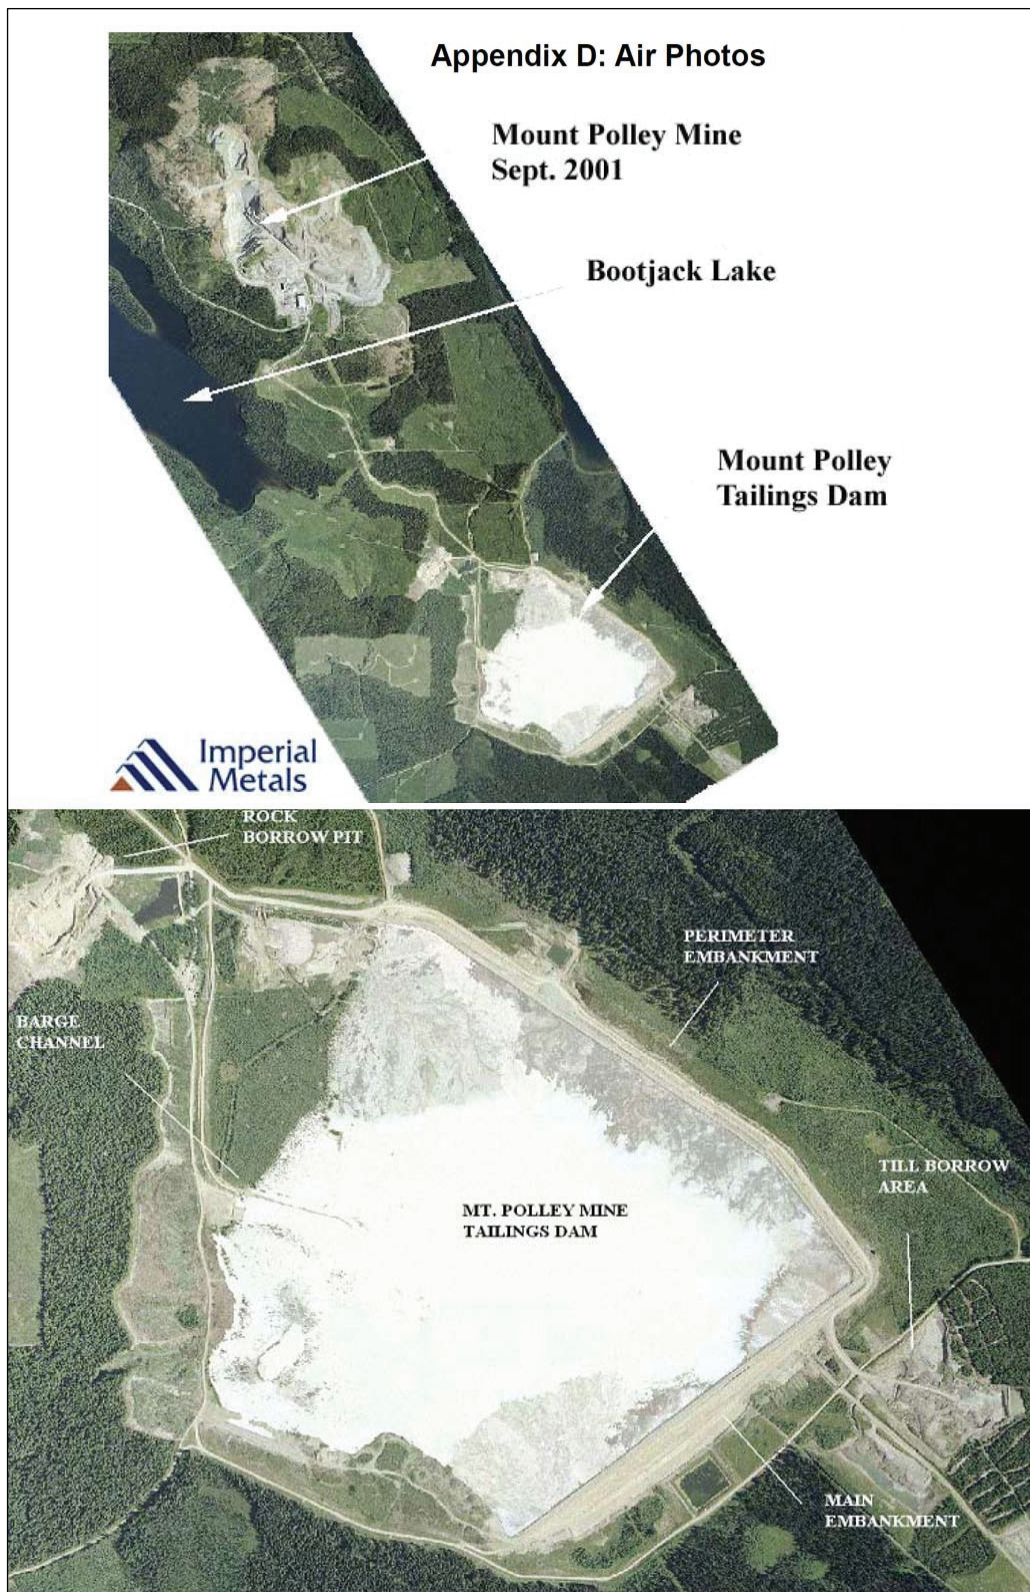
Above: Same air photo of Mount Polley mine and TSF, used as Appendixes in two technical reports: *Feasibility Study: Springer and Bell Pits Mount Molley Mine*, August 30, 2002, Appendix A; and *Mount Polley Mine 2004*, August 1, 2004, Appendix D. Besides providing intelligence on the state of the TSF in September 2001, there is something very odd about this photo. The supernatant pond appears to be white, almost as though it is covered in ice, while Bootjack Lake is a dark blue color, without ice or snow. It leads to a logical question on whether or not the TSF portion of the air photo may have been doctored, photo-shopped, or manipulated.

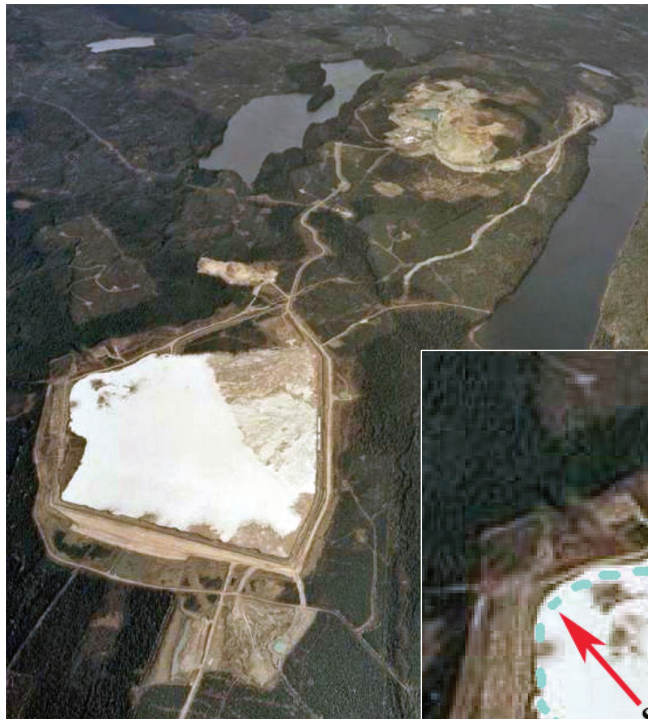
Aerial Photo, October 2005, and cut-out close-up, as shown in Figure 1.1 of Knight Piésold's 2008 TSF inspection report. The concerns about supernatant pond location movement due to concentrated tailings deposition from single-point or uneven spigot discharging from the three Embankments go back to the "Care and Maintenance" years. In October 2005, the crest elevation of the dam was about 951 meters.

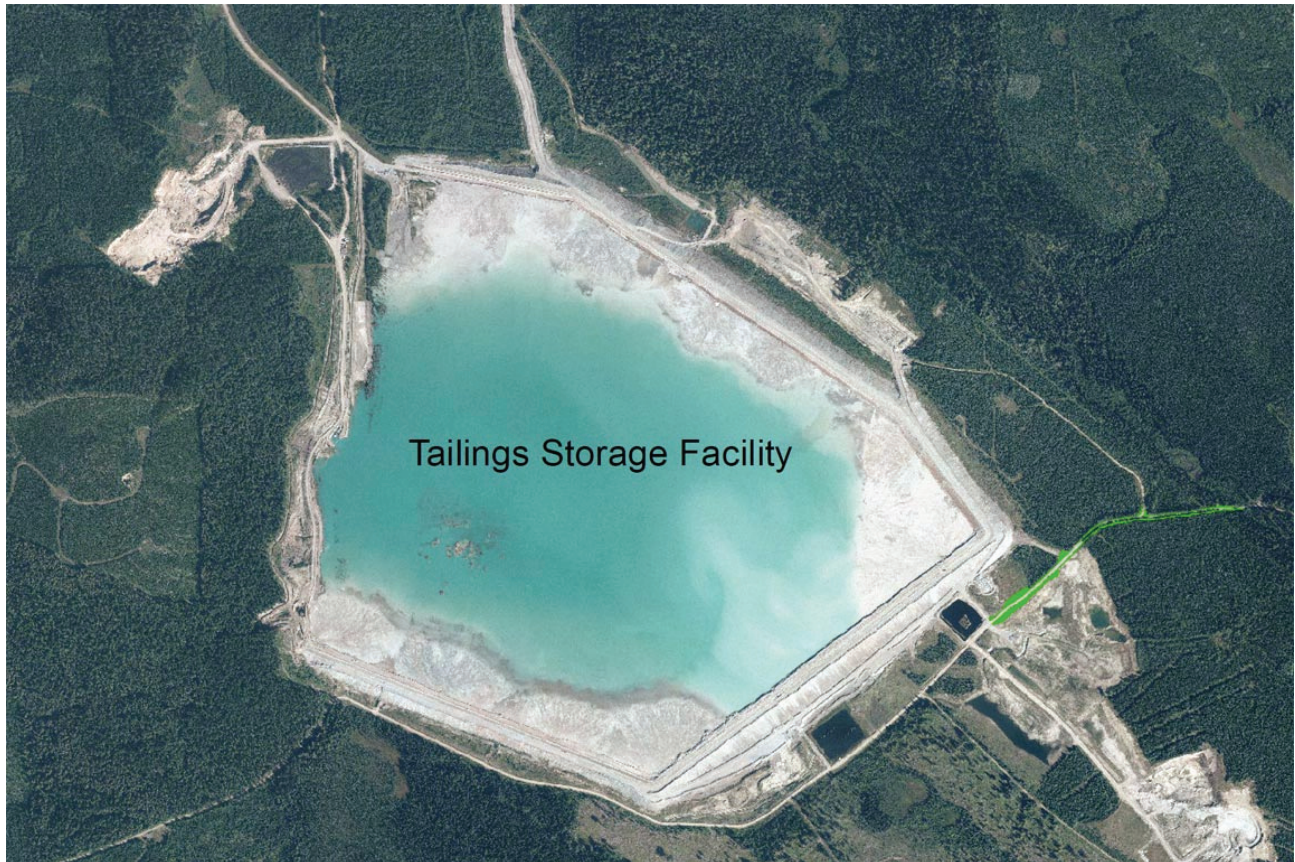
Above: an undated aerial photo used in Figure 7.1, *Disturbed and Reclaimed Surfaces 2011*, in the 2011 *Annual Environmental and Reclamation Report*. Note the location of the supernatant pond adjoining half the mid-crest length of the Main Embankment. The configuration of the pond is roughly similar to the May 15, 2010 satellite image above.

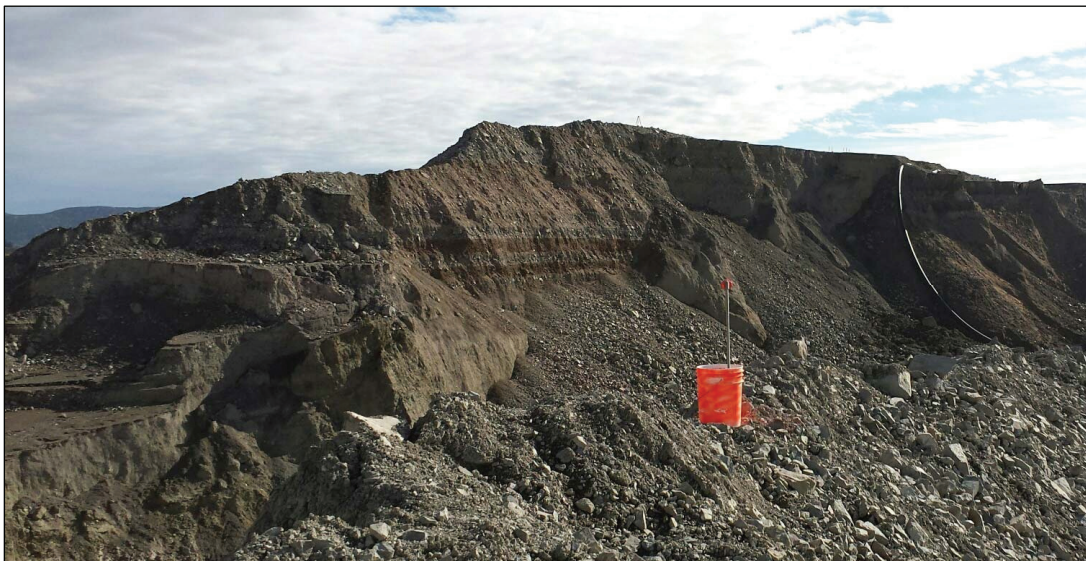
Photo, October 2014. The remains of the 35-40 meter high Perimeter Embankment, on the south side of the breach. Note the layers exposed, showing the Upstream Method stage-phased construction materials facing to the inside of the dysfunctional TSF.

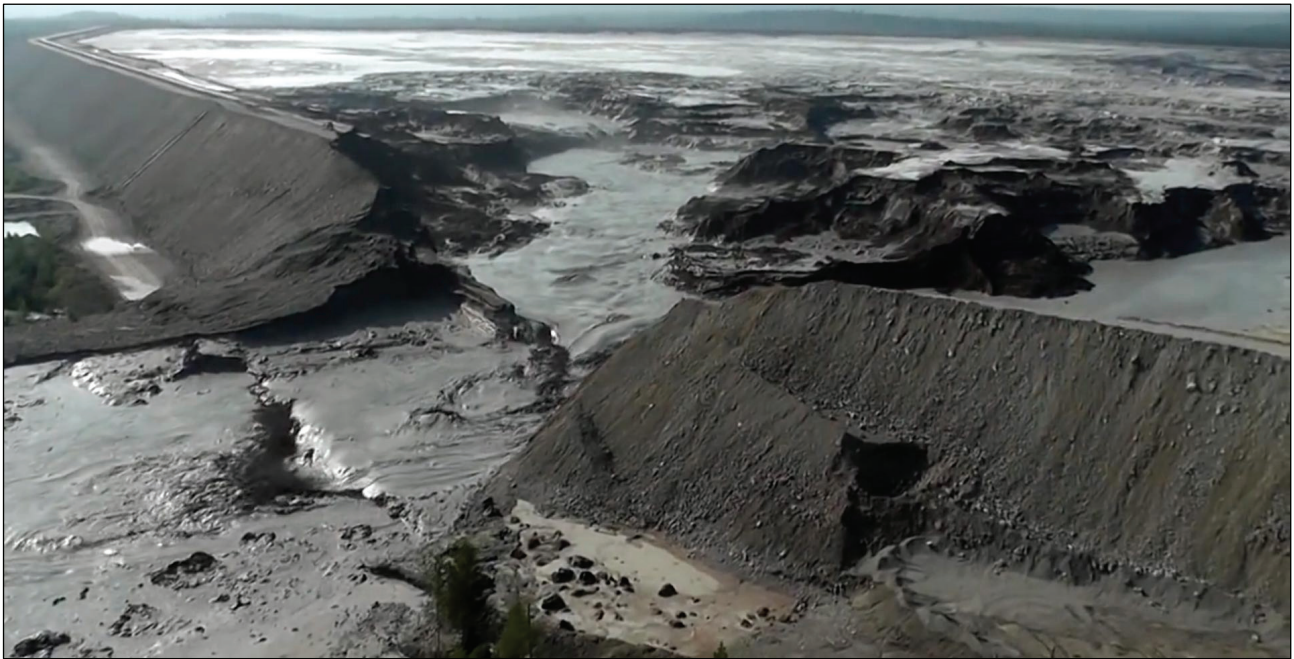
August 4, 2014 image of the Mount Polley Tailings Storage Facility from the helicopter flight showing the breach at the northern end of the Perimeter embankment. The height of the embankment, at the far left of the image, from the road to dam crest, is almost 40 meters. Note the sinkhole/depression at the outer edge of the breach area and remaining slump of embankment material located just above the sinkhole area. After initial burst flows of water and tailings began to subside from the tailings mass to the far right of the image, cascading, draining flows then began to unravel from the center area of the image. According to company records, the total area of the Tailings Facility is about 235 hectares.

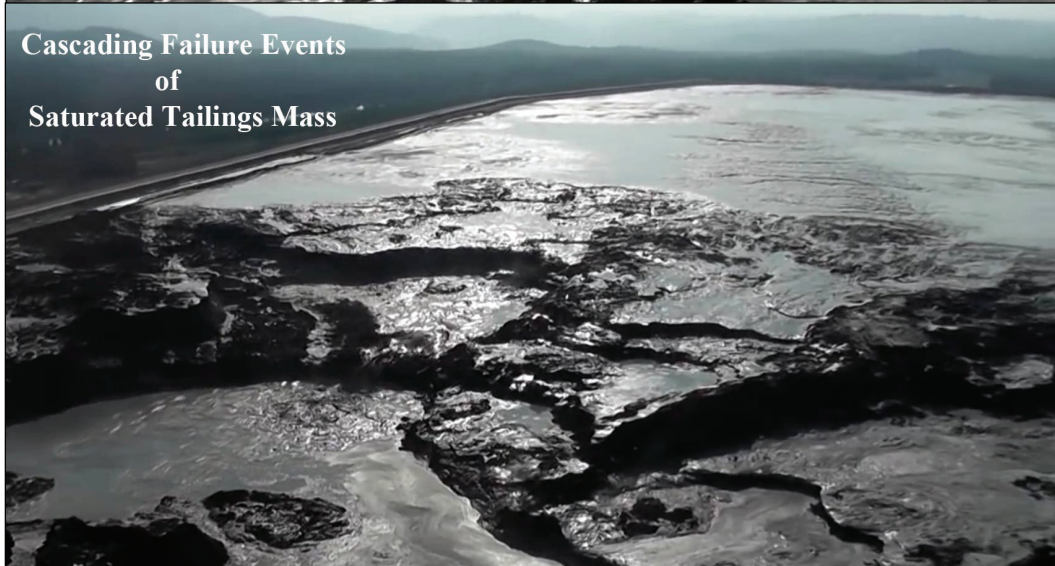
Images from August 4, 2014 helicopter flight. They show the state of the disaster about 5 hours after the breach occurred, during the second phase of draining, cascading physical collapsing of the saturated tailings mass, the forces of which affected the integrity of the 3 embankments.

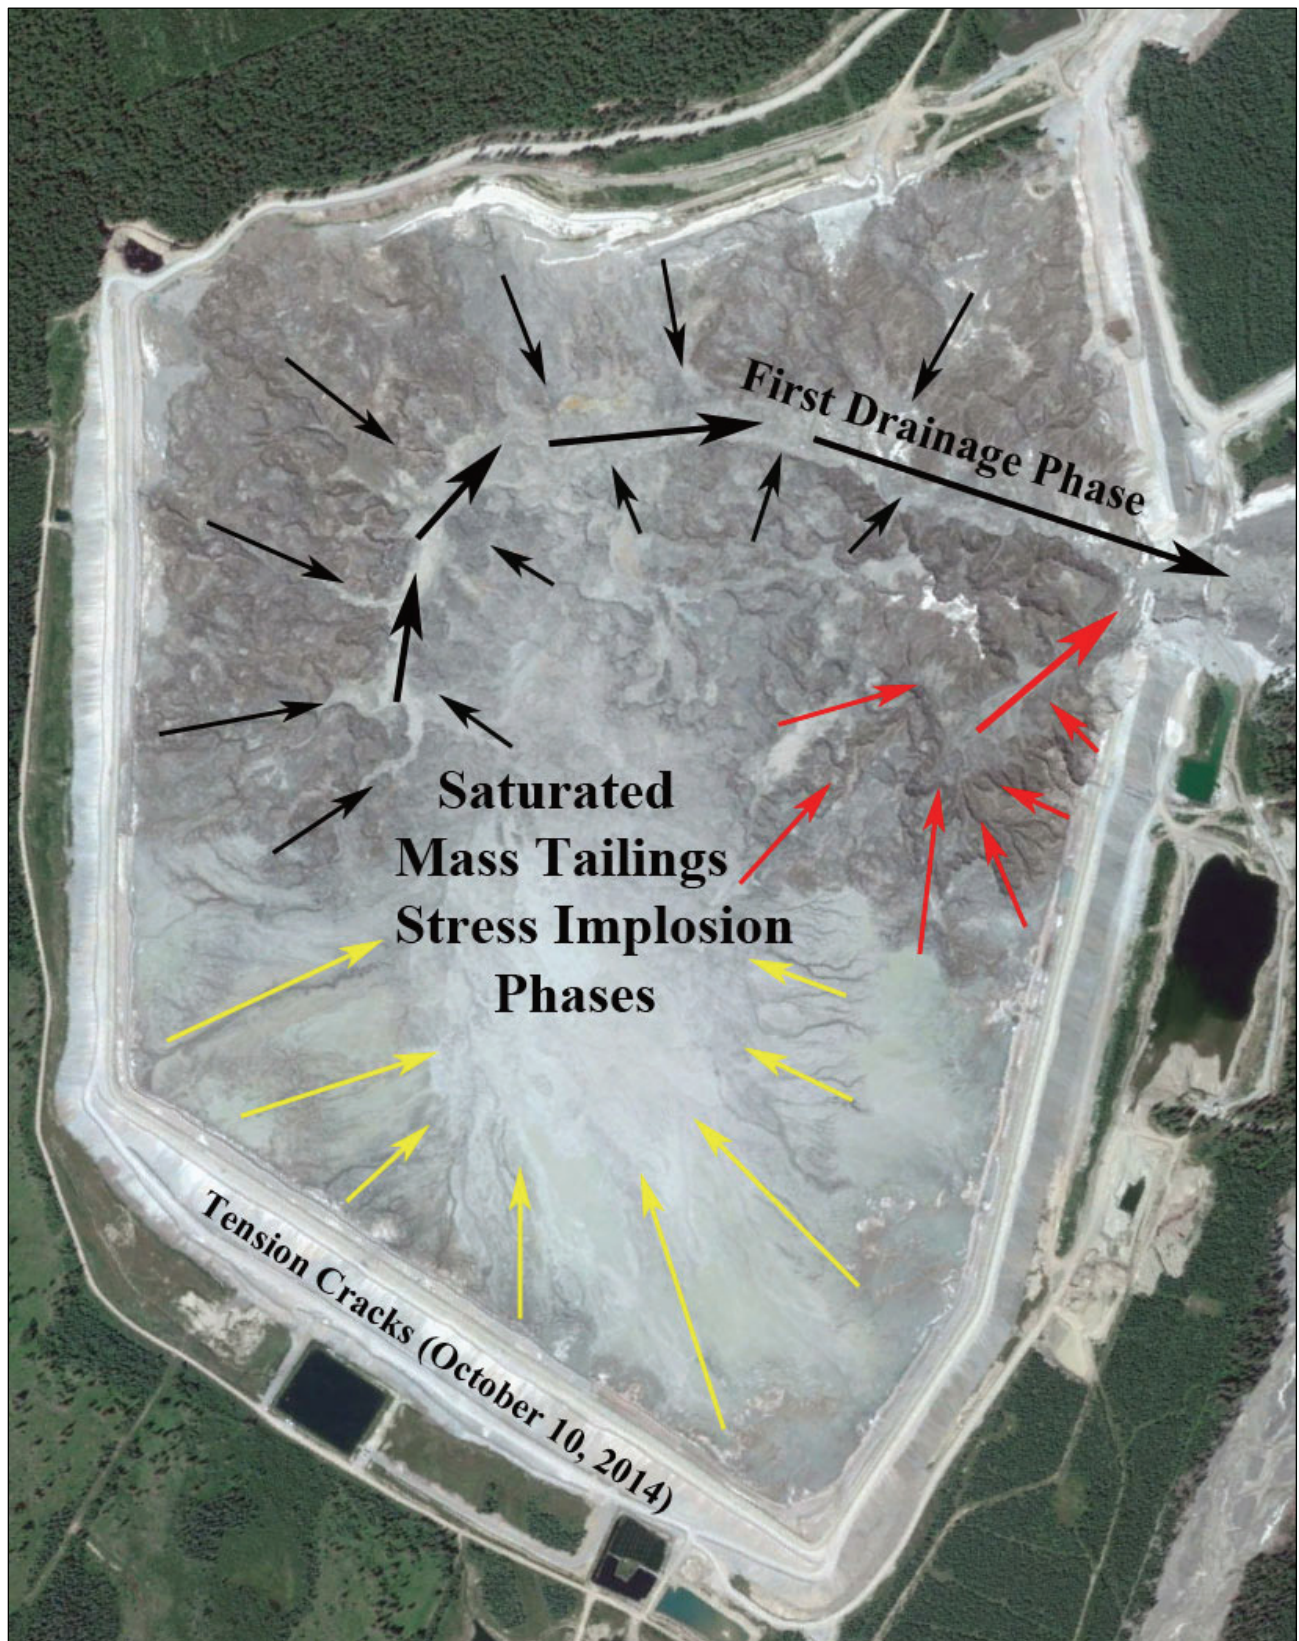
August 9, 2014 Google Earth Satellite Imagery showing a much-interstitial-water drained Mount Polley TSF. The black arrows indicate the initial burst phase and mass tailings movement, which primarily drained along the original curved 930 meter land base elevation contour line. The red arrows indicate the second mass tailings phase, after the initial phase subsided, causing more cascading events of the heavily laden saturated tailings. As both phases of the draining TSF evolved, the third phase, yellow arrows, began draining the farthest reaches of the tailings mass situated about 1.4 kilometres distant by the Main Embankment, the stresses of which most likely initiated tension cracks on its crest.

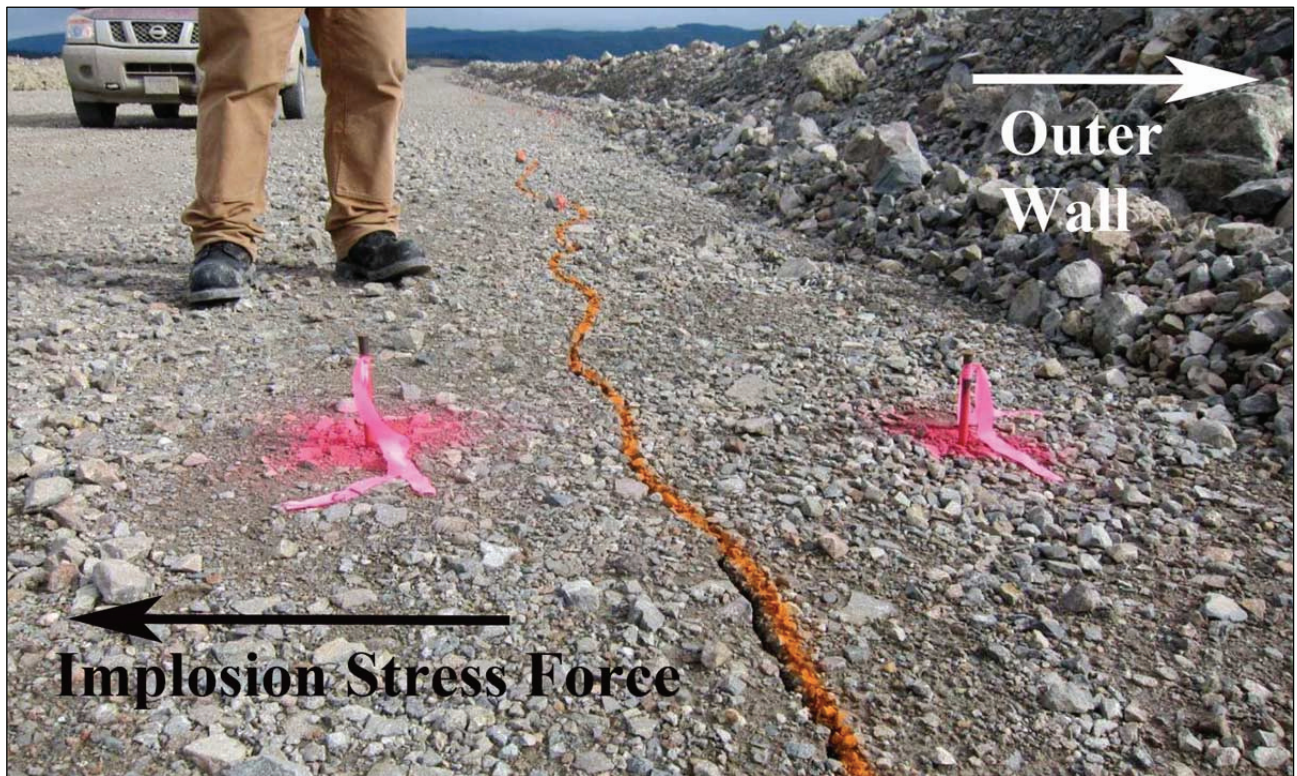
Tension Cracks observed on Main Embankment Crest on October 10, 2014

Above: The photo above shows a 150-meter-long tension crack first discovered on the crest of the Main Embankment on October 10, 2014. The pink-flagged and spray-bombed spikes are “extensometer pins” to physically measure movement changes made to the separation growth or lateral expansion of the tension crack. The originating cause of this tension crack was undoubtedly due to the imploding, dramatic stress forces made to the former equilibrium state of the saturated (pore water) tailings mass, forces of which may have physically altered the stage-phased structural Upstream-method layered integrity of the three embankments. It is not known how deep this tension crack is, or if it is an indication of a more serious and convoluted internal structural concern. According to additional information in the October 11, 2014 *Tailings Storage Facility Breach Mitigation* update by BGC Engineering Inc., “additional cracks were observed between chainage 2+119 and 2+162” meters.

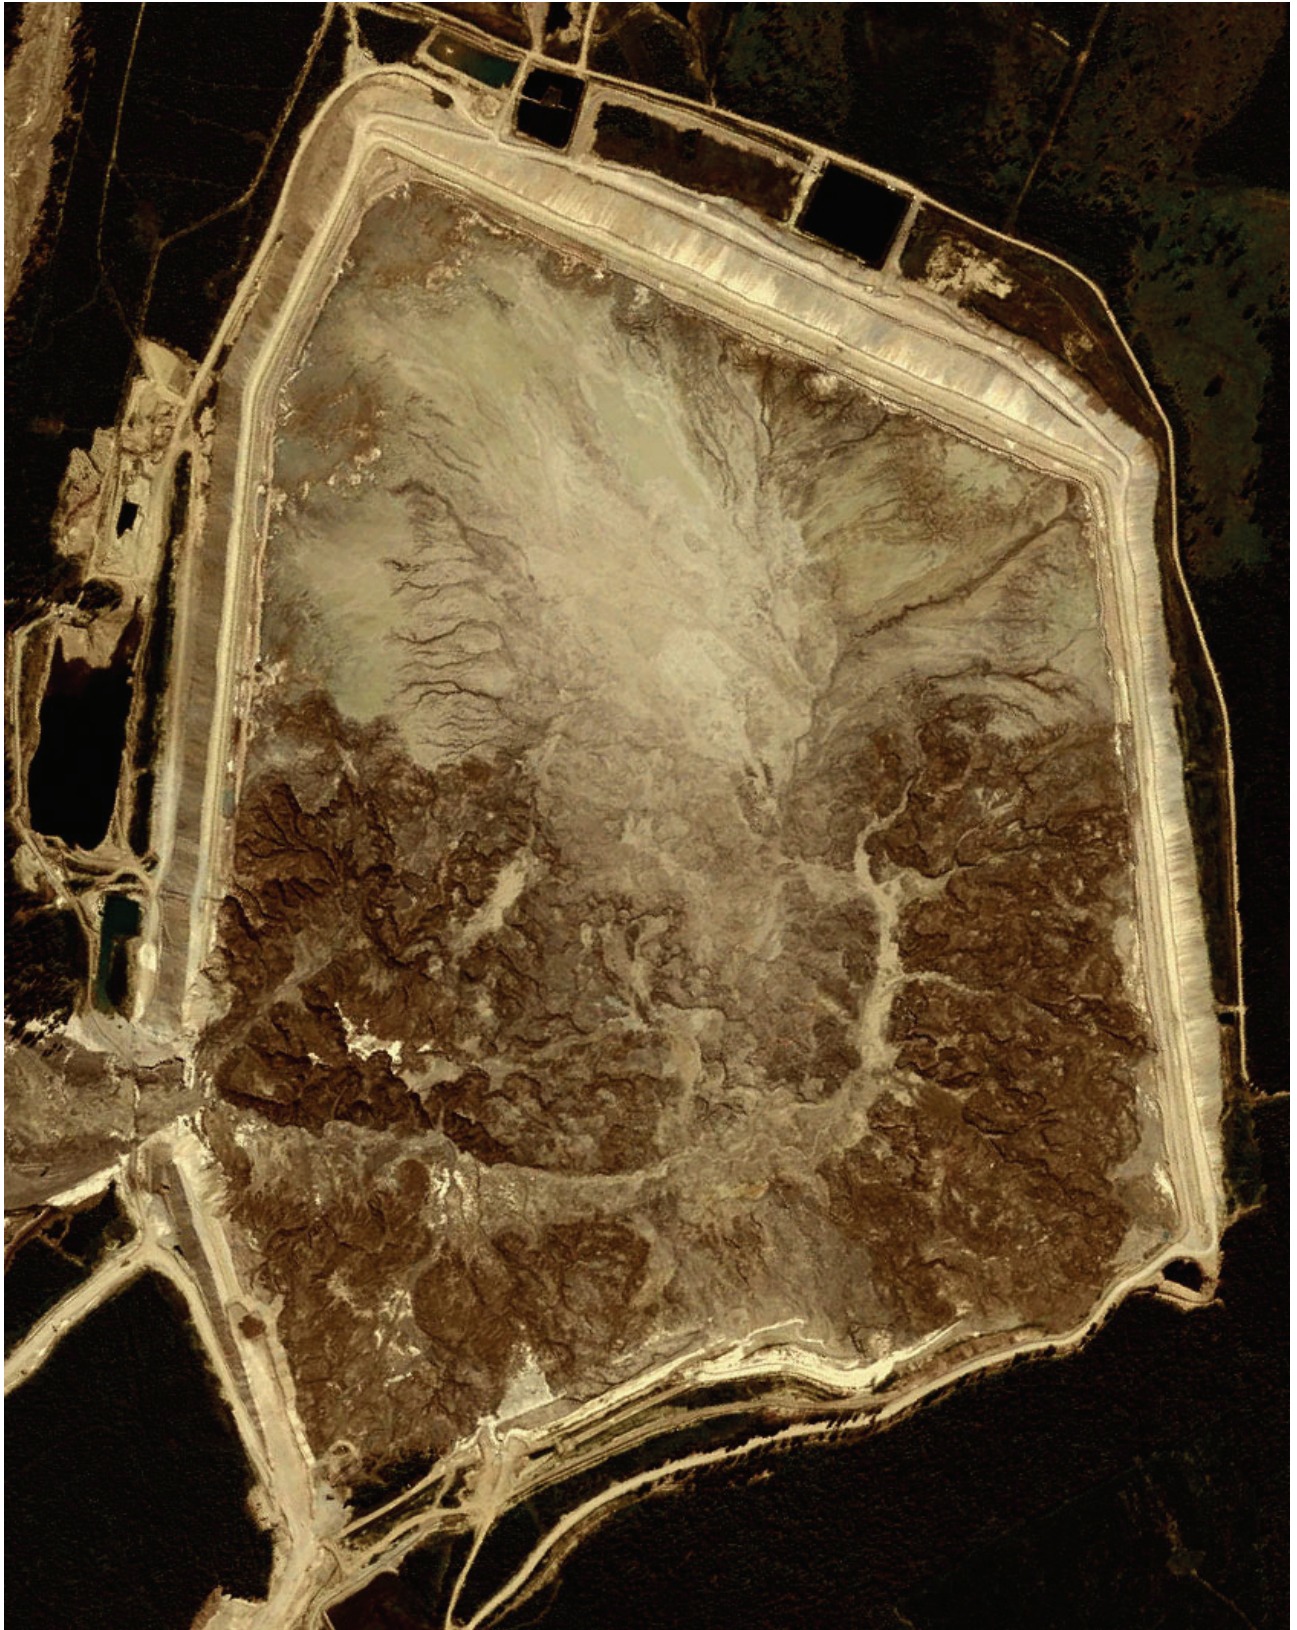
Photoshop rendering of Google Earth satellite image of Mount Polley TSF, using “neutrals” variable settings in “selective color” adjustment in Photoshop, to better highlight the saturated mass tailings implosion flow exit paths, dendritic drainage patterns, and lateral stress forces. The darker brown areas denote the depleted and collapsed tailings mass, while the lighter zone on the top half shows the compressed tailings mass.
