**Watershed Assessment of Proposed Forest Development  
within the  
Peachland Creek Community Watershed**

**Revised Final Report**

**November 5, 2018**

**Rob Scherer, Ph.D., P.Eng.  
Forest Hydrology Consulting  
Kelowna, BC**

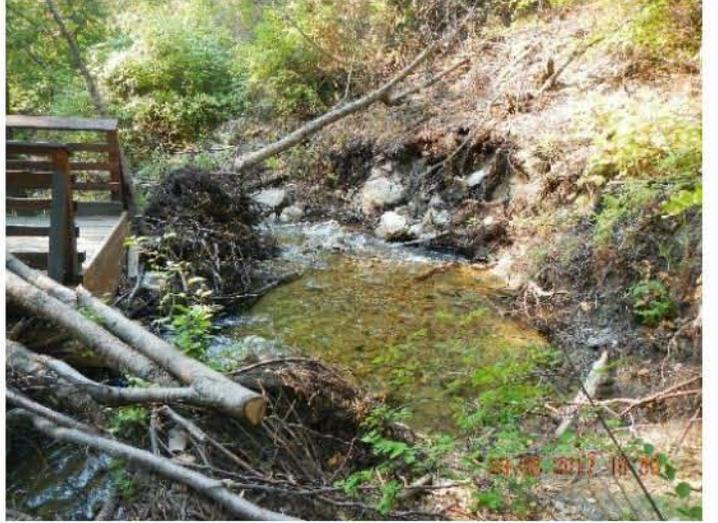
**Photo #2 (Field Stop 1):**

Lower reach of Peachland Creek below Hardy Falls was actively eroded in the 2017 spring freshet. Forced riffles placed to create fish habitat were undermined.

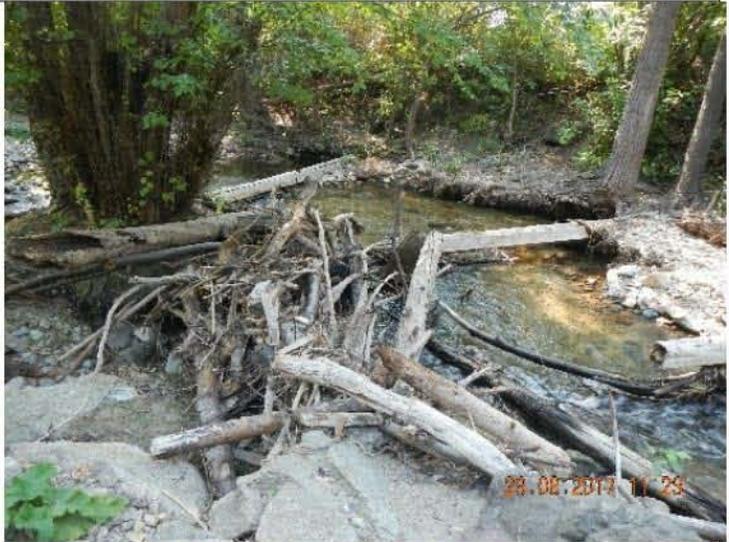
**Photo #3 (Field Stop 1):**

Peachland Creek is directly adjacent to homes situated below Renfrew Road. Channel bank below homes is highly erodible.

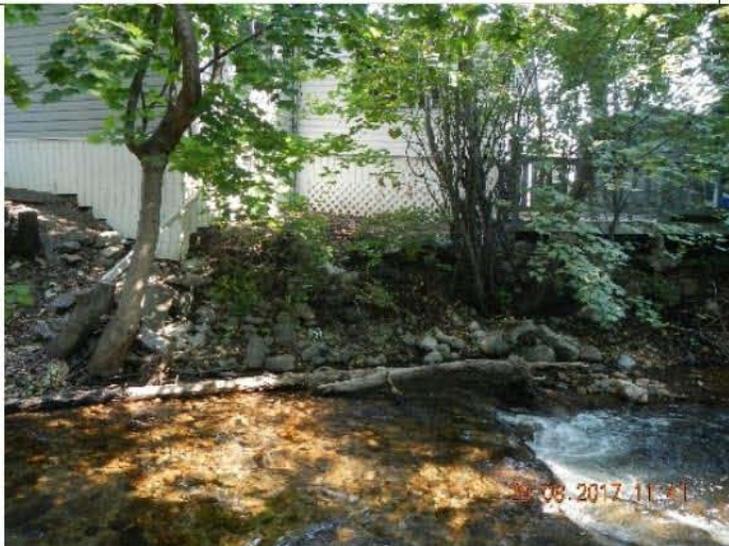
**Photo #4 (Field Stop 2):**

Stable, Cascade-Pool (Boulder/Cobble) channel. Channel was moderately disturbed as result of high streamflows and a landslide that occurred approximately 250 m upstream. Munro FSR is a significant contributor of fine sediment into Peachland Creek. The District of Peachland water intake is only located ~ 250 m downstream.

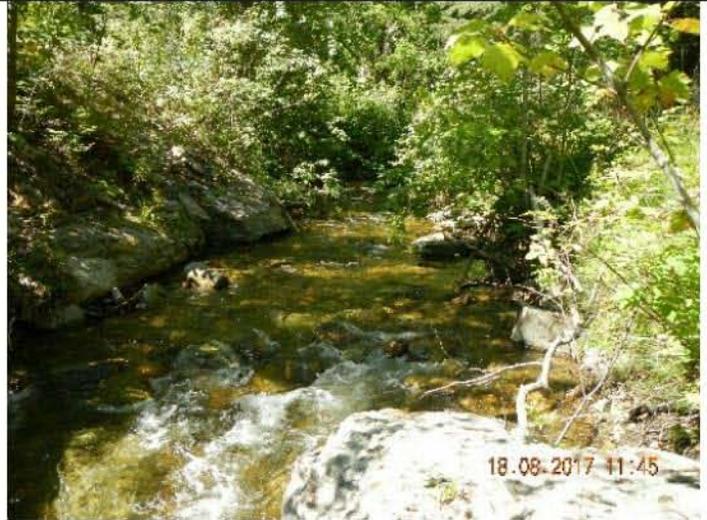
**Photo #5 (Field Stop #3):**

In 2017 channel was relocated approximately 30 metres to east of original location of channel as result of landslide below the Munro FSR that occurred on April 28, 2017. Channel banks are unvegetated and likely stabilize over next few spring freshets.

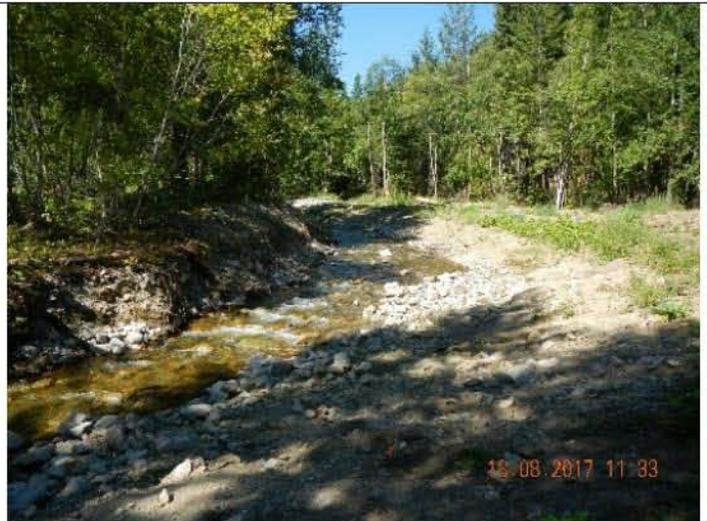
**Photo #6 (Field Stop #3):**

Landslide directly impacted Peachland Creek subsequent to this event ~120 m of Peachland Creek was relocated to the eastside of the partially confined channel valley.

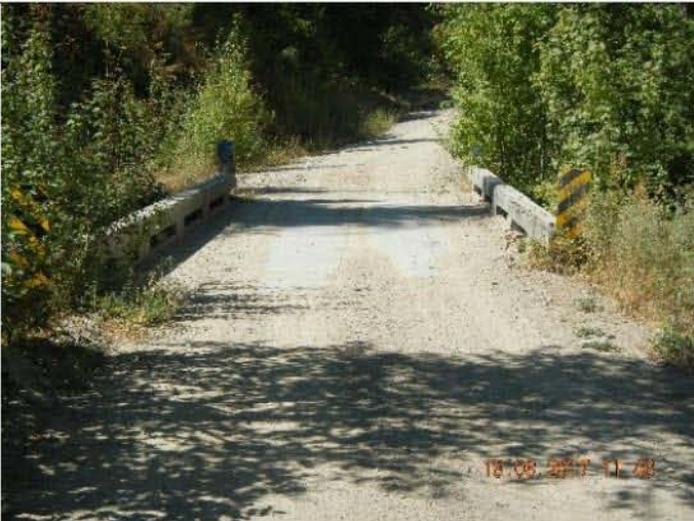
**Photo #10 (Field Stop #2):**

Barrier used to minimize delivery of sediment off of the bridge deck into Peachland Creek requires maintenance.

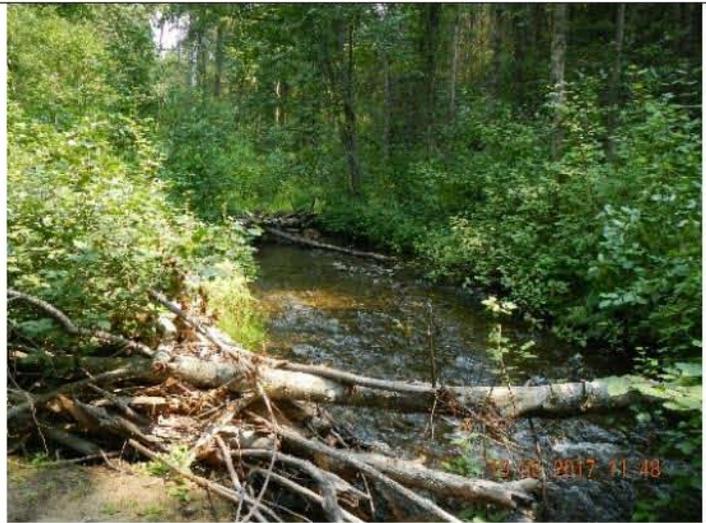
**Photo #24 (Field Stop #22):**

Partially Degraded, Step-Pool (Boulder/Cobble) channel. Old trail has been overtopped and Mile Creek has eroded the trail

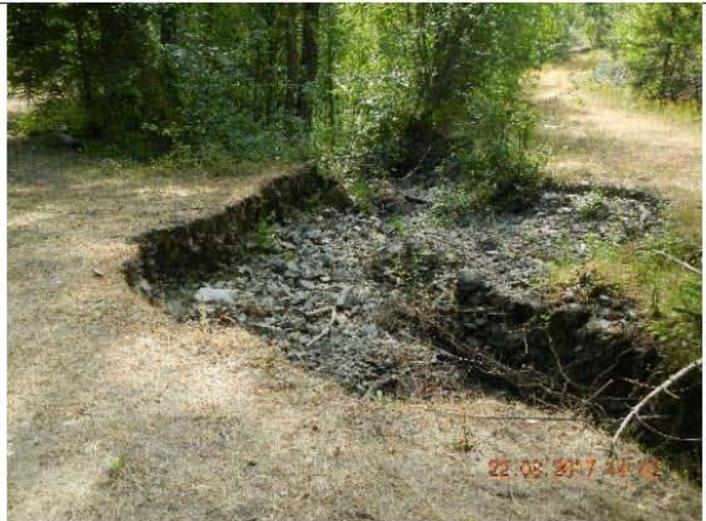
**Photo #25 (Field Stop #24):**

Old trail has been overtopped and gully has been created (1 m wide x 4 m long x 0.5 m deep)

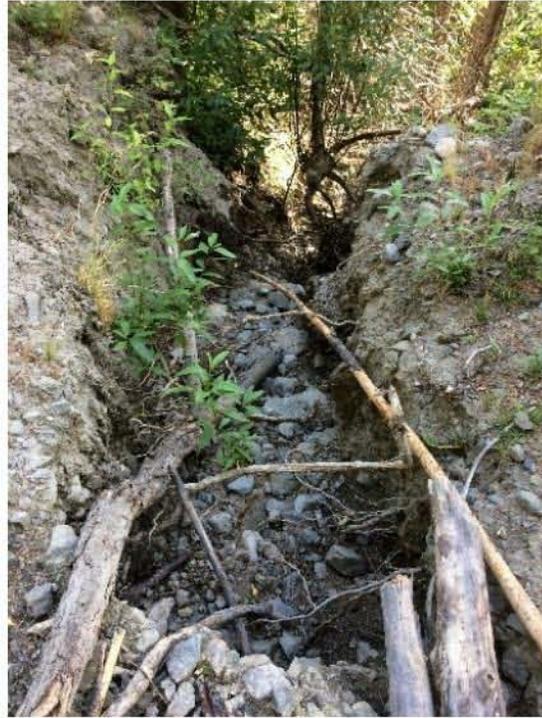
**Photo #26 (Field Stop #26):**

Debris flow track is partially vegetated and sediment fence has been used to contain sand/gravel.

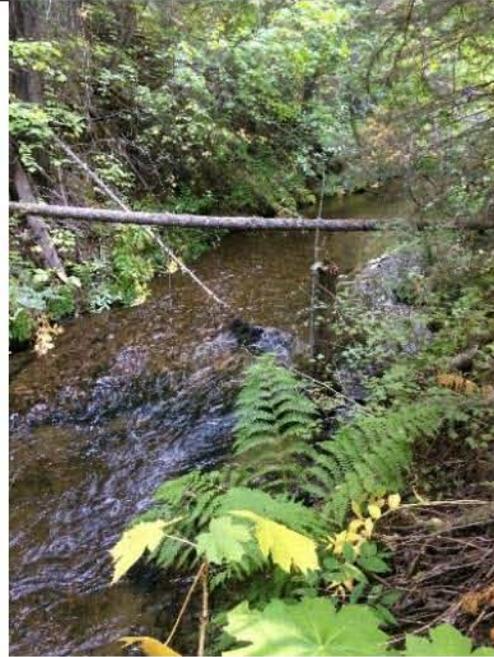
**Photo #28 (Field Stop #32):**

Two fill slope failures are located in this area. A small tributary has overtopped the old trail and has created a gully. Recent harvesting in 2015 (KP1032) is located directly upslope ~30 – 50 m. Water was diverted down a dichline off of a trail that connects with the lower trail. Slope failure is directly connected to Peachland Creek. Gully in photo is approximately 2 m deep.

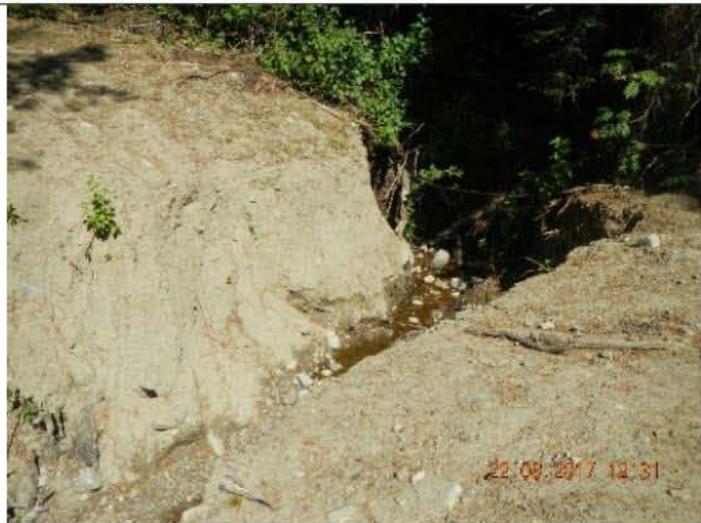
**Photo #29 (Field Stop #32):**

Two fill slope failures are located in this area. A small tributary has overtopped the old trail and has created a gully. Recent harvesting in 2015 (KP1032) is located directly upslope ~30 – 50 m. Water was diverted down a dichline off of a trail that connects with the lower trail. Slope failure is directly connected to Peachland Creek

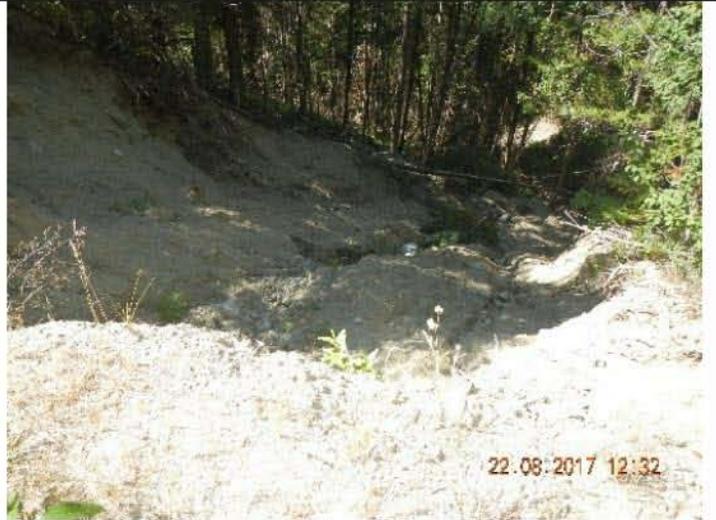
**Photo #30 (Field Stop #33 to 36):**

Culvert inlet is plugged at the Brenda Mines Road crossing over Mile Creek. A pond above the road overtopped and eroded the ditchline for >400 m down Brenda Mines Road. Road ditchline was repaired in the summer of 2017 after this photo was taken.

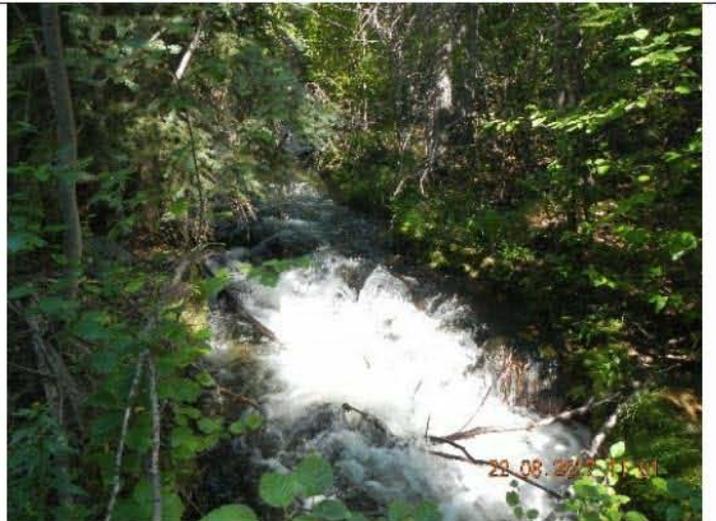
**Photo #38 (Field Stop #38):**

East end of diversion ditch from Peachland Lake drains onto steep valley slope. A large gully has been eroded in the steep valley slope as result of flow from diversion ditch.

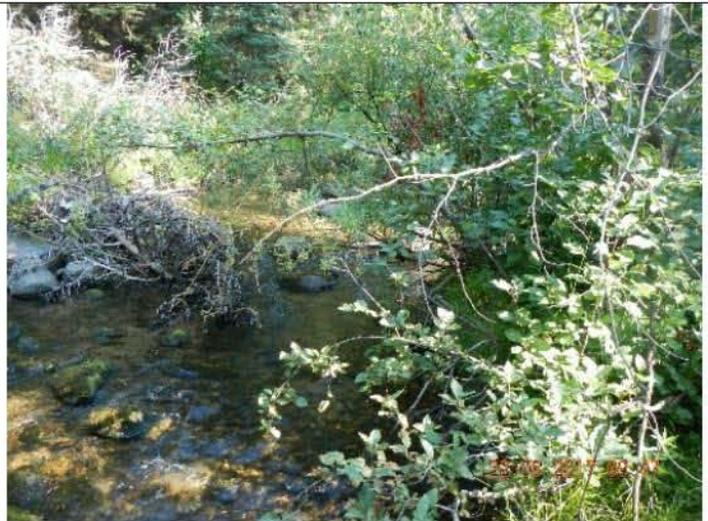
**Photo #40 (Field Stop #41-42):**

- Field Stop #41 and 42 (Photo 40) – Two wood culverts situated at two tributaries to Peachland Lake have failed

Partially Degraded, Cascade-Pool (Cobble) channel. 1990's logging. Wood culvert has failed.

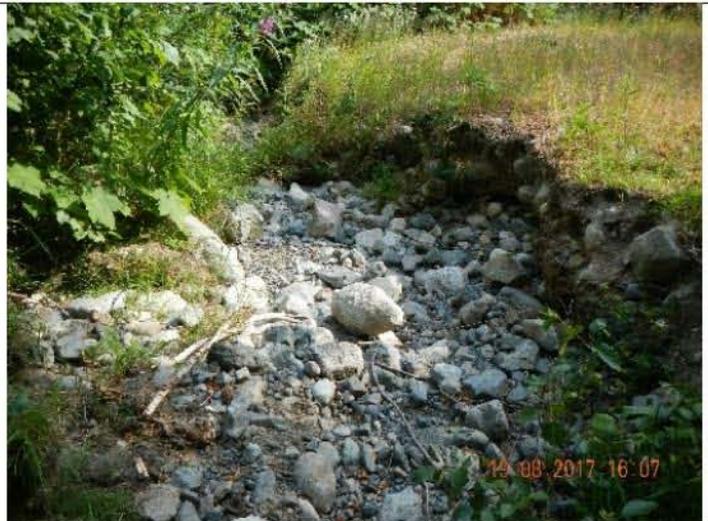
**Photo #41 (Field Stop #46):**

Partially Degraded, Step-Pool (Cobble) channel. Moderate to low bank erosion. Exposed fine roots along banks. Channel overtopped bankfull in the spring of 2017.

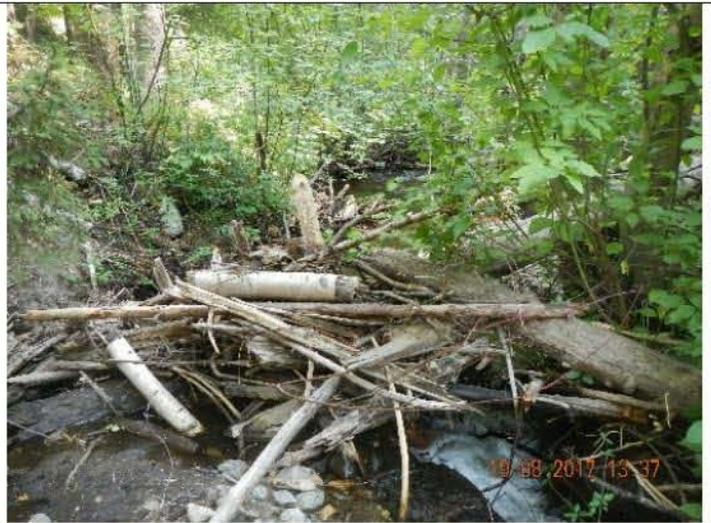
**Photo #43 (Field Stop #48):**

Partially aggraded, Cascade-Pool (Cobble) channel. Numerous elevated channel bars with sand and gravel along edges of channel. Minor bank erosion.

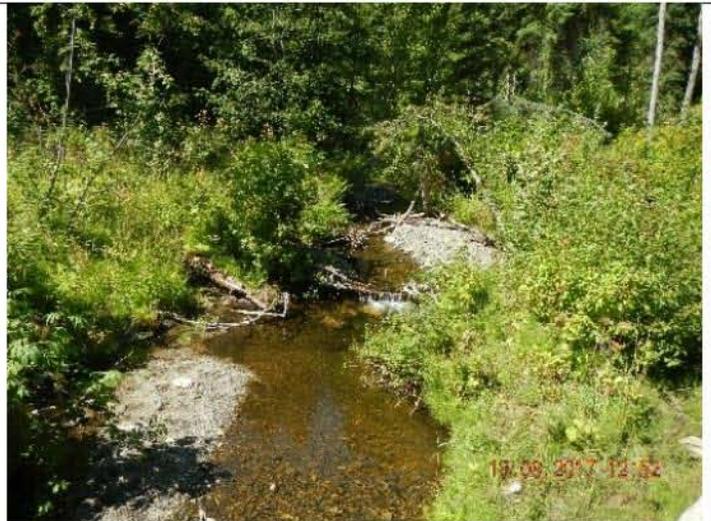
**Photo #44 (Field Stop #50):**

Small failure above and below crossing. Highly erodible sandy silts. Fine sediment delivery is directly connected to Greata Creek.
