British Columbia's Mount Polley copper/gold/silver mine waste tailings disaster of August 4, 2014, located near the western-most reach of Quesnel Lake, is among the largest recorded disasters, by volume, in world history, with updated estimates of about 25 million cubic meters of toxic waters and heavy metal mine waste contaminants having escaped into the nearby environments of Hazeltine Creek and Quesnel Lake, destroying and inundating everything in its path, a most terrible and preventable tragedy.

This is the first investigative report on Mount Polley since the date of the disaster, 17 weeks previous, and provides an assessment and introductory history behind the inner workings of a terrible tragedy, of what appears to be an environmental crime. And, it is published during a time of interim darkness, as the BC government is temporarily withholding report and related information not already released concerning the planning and operations of the Mount Polley mine, perhaps until the early months of 2015 or later. That is when the reporting of one of a few separate investigations is scheduled for public release: a government-appointed three-panel member review committee (under narr

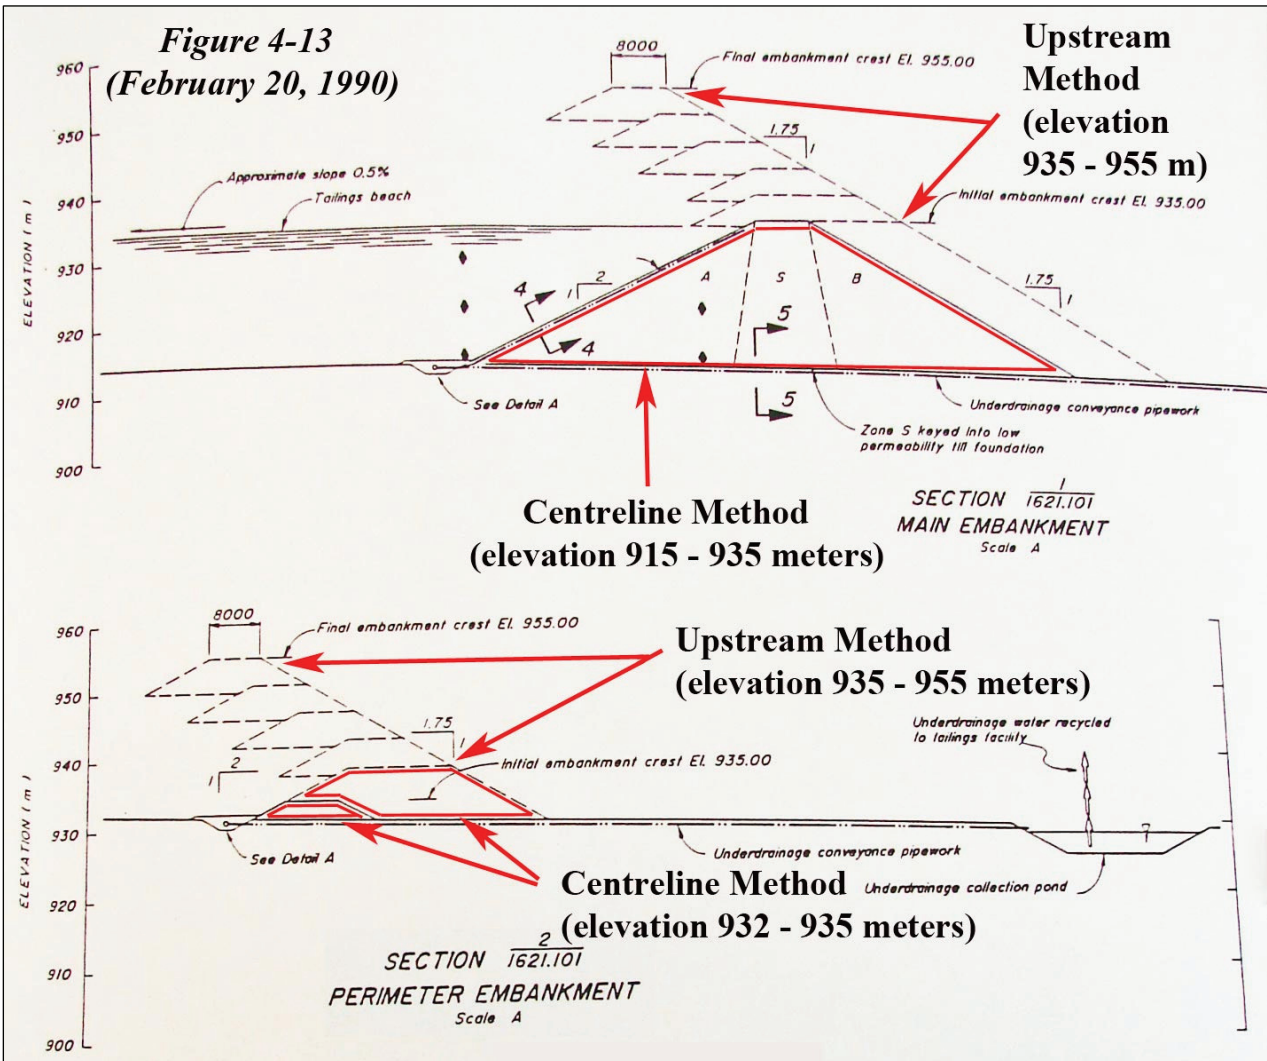
Above: Figure 4-13 from the 1990 report, *Tailings Storage Facility Embankment Sections and Details*, showing the Centreline and Upstream methods for the 'Main' and 'Perimeter' Embankments of the proposed Mount Polley TSF.

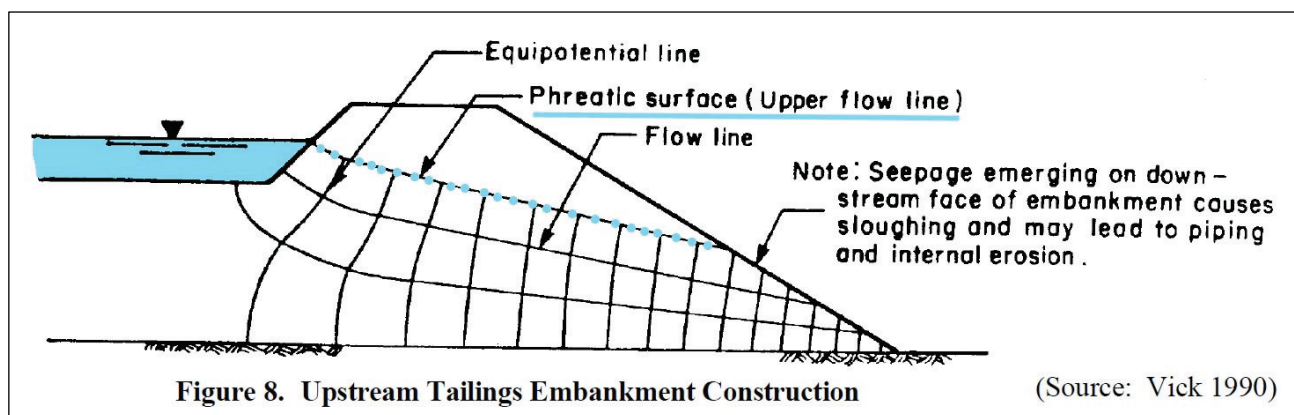
*Above: Diagram from EPA's 1994 report, *Design and Evaluation of Tailings Dams*. The blue zone is the location of water (supernatant, accumulating) in a tailings facility, and the dotted blue line is the Phreatic (water table) upper surface zone emanating through gravity from the supernatant (decant) water held in the facility.*

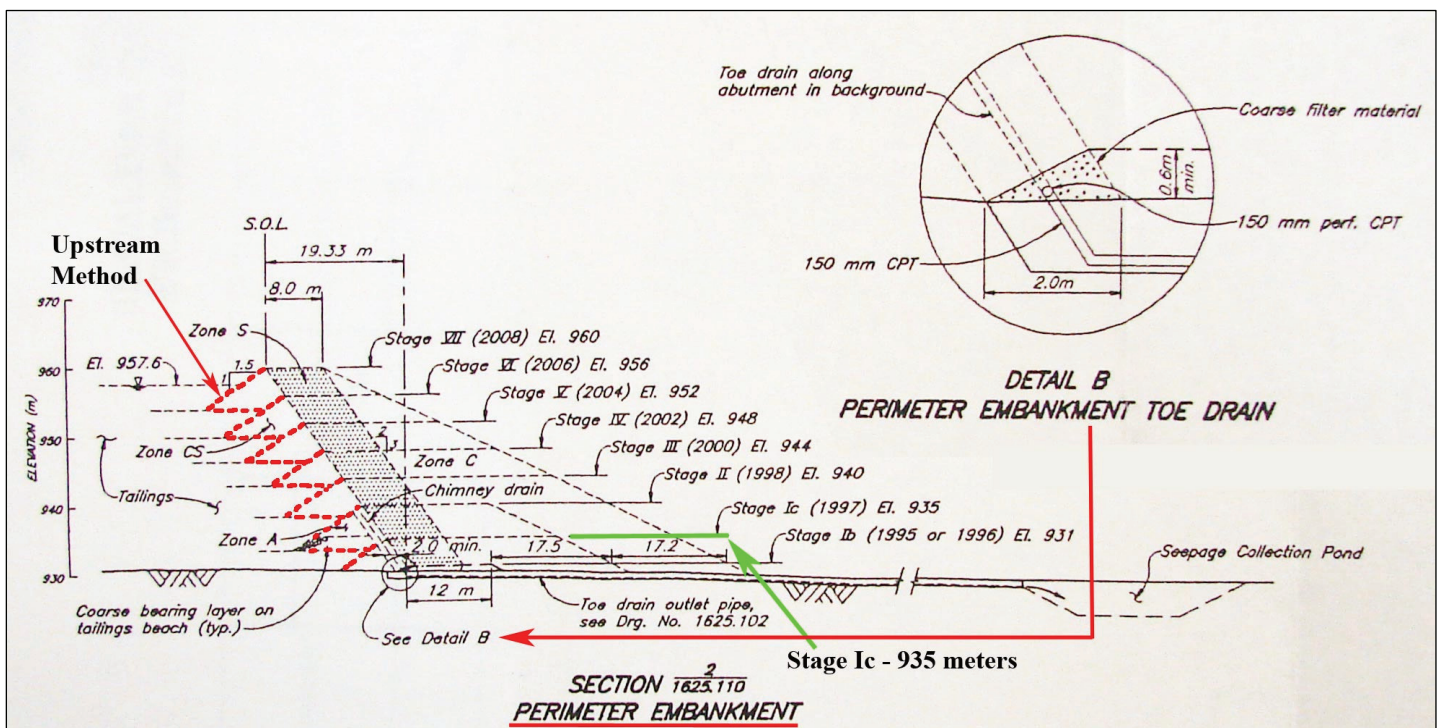
Above: Figure 3.18 from 1996 *Reclamation Plan* report. The red dotted lines show the Upstream Type method stages for the Main Embankment. Note the height in meters of Stage Ic elevation, and the large area below built up primarily of Centreline Type method, a much stronger foundation area than provided for the Perimeter Embankment foundation.

Below: Figure 3.18 from 1996 *Reclamation Plan* report. The red dotted lines show the Upstream Type method stages for the Perimeter Embankment, a section of which failed on August 4, 2014. Note the shallow base constructed for the Centreline Type method, compared to the higher and wider zone provided for the Main Embankment above.

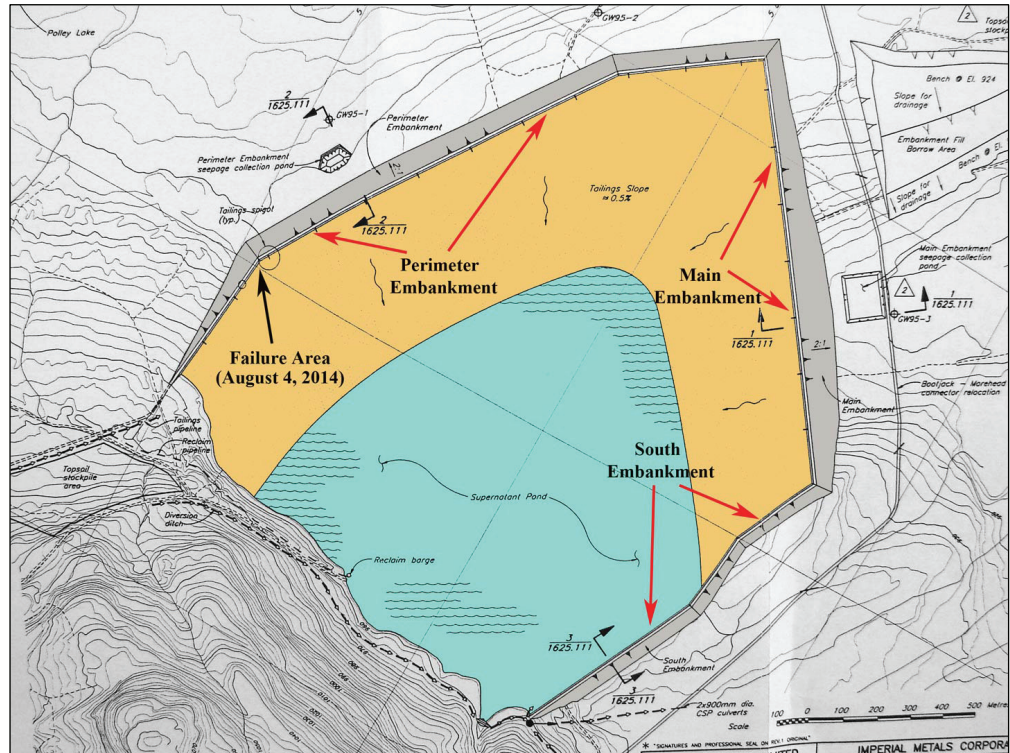
Right: Figure 3.16, *Tailings Storage Facility Final Arrangement*, from the 1996 *Final Reclamation* report. The locations of the three embankments are named, showing the ‘conceptual’ location of the supernatant waters (in blue-green) well away from the higher Perimeter and Main Embankments (plenty of “freeboard”). In the area of exposed tailings are small indicators showing the integrated locations of tailings spigots (along the outer perimeter of the tan color area).

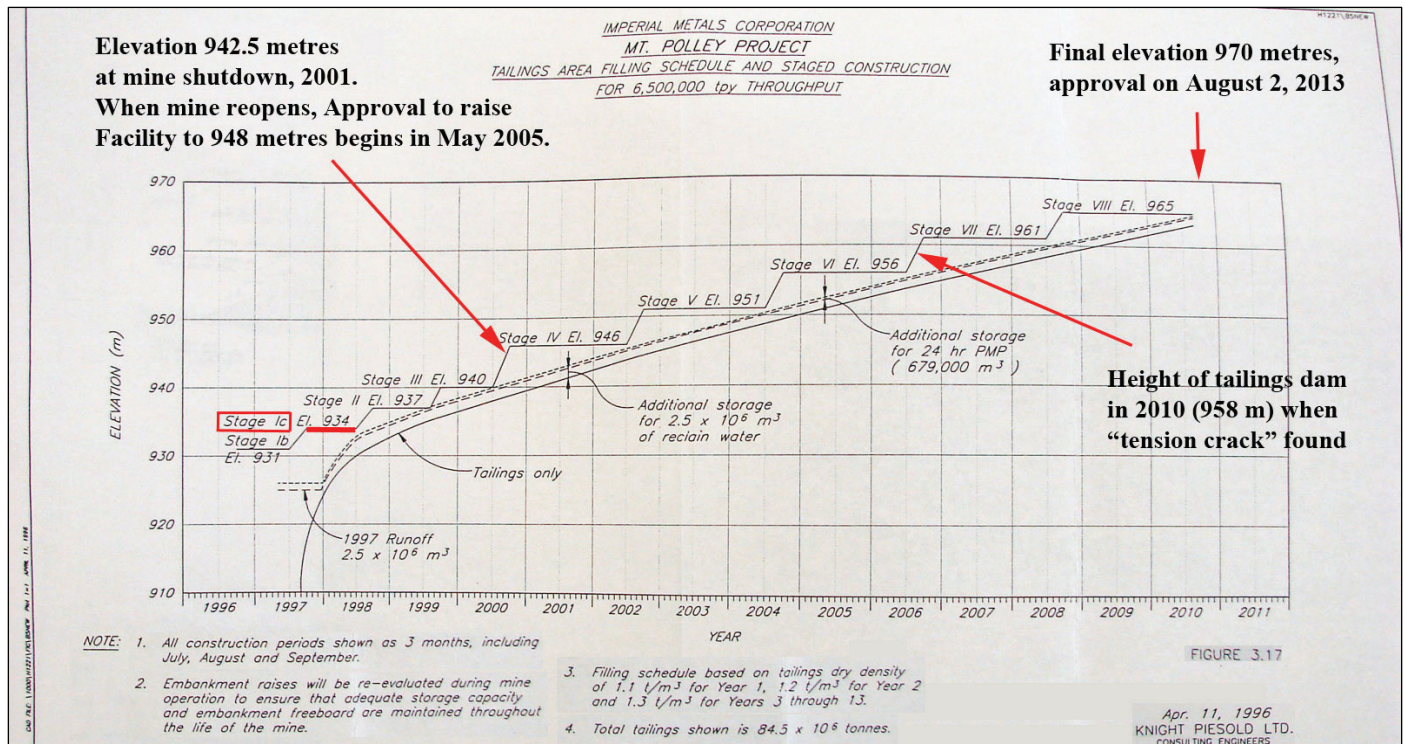
Below: Figure 3.17, *Tailings Area Filling Schedule and Staged Construction*, in the 1996 *Reclamation Plan* report. This was Knight Piesold’s long-term staged elevation construction concept for the TSF, based on a 14-year-long mine life. The TSF became ‘dormant,’ so to speak, from October 2001 to March 2005 (referred to by Mount Polley Mines Corp. as the “care and maintenance period,” when the TSF collected large volumes of groundwater, rain & snow. Note: the 2009 *Technical Assessment Report* states that it was “a substantial accumulation of water”. From 2005 to 2014, the embankments were raised almost 22 meters in total crest height, a period when the mine plan was revised to accommodate newly discovered ore bodies with a projected new mine life expected to last to about the year 2025.

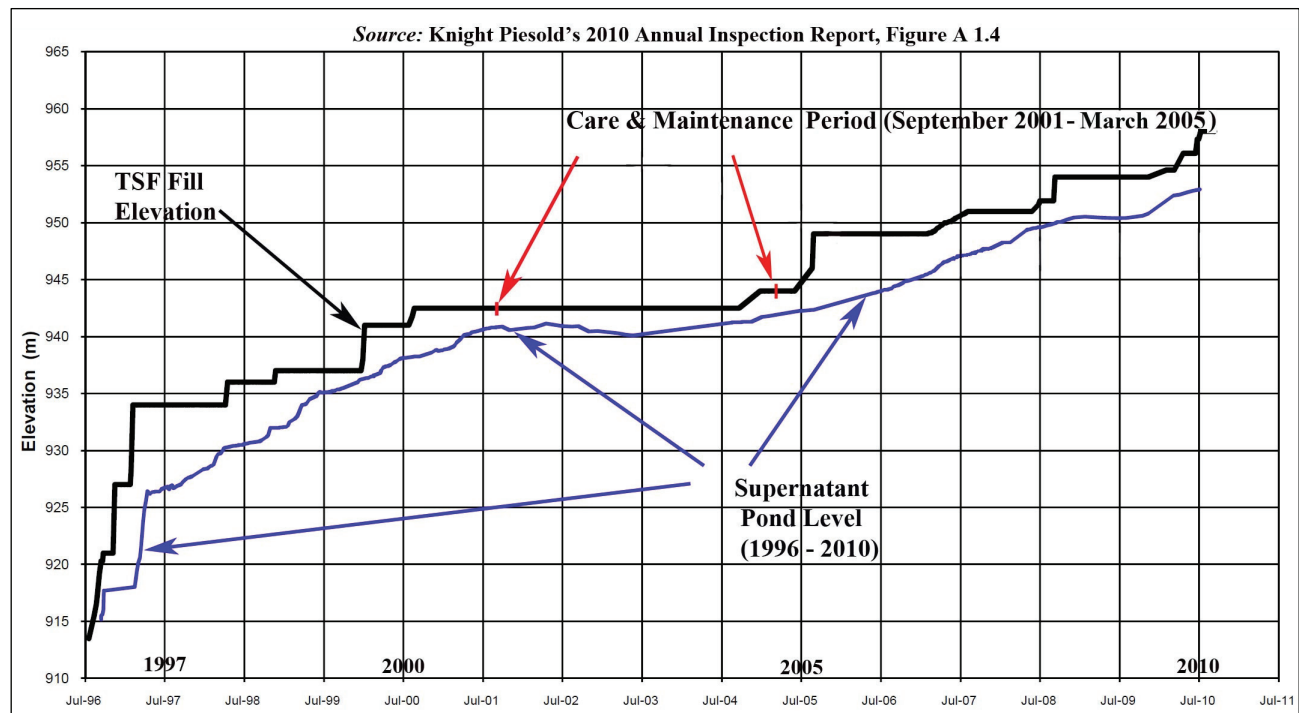
Below: Graph from Knight Piesold's 2010 Annual TSF inspection report showing the evolution of the crest height of the Mount Polley TS from July 1996 to July 2010.

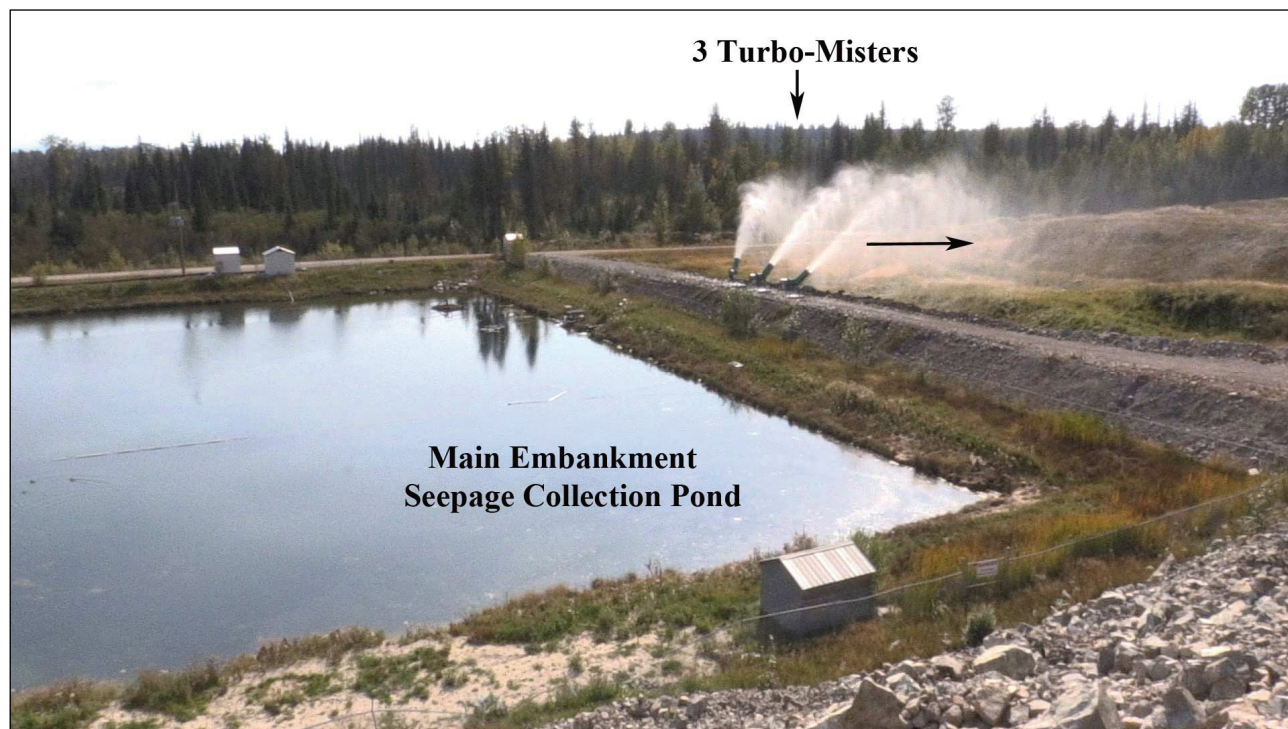
During a tour of the TSF on September 16, 2014, the author photographed three “Turbo-misters” actively discharging untreated mine waste finely sprayed water from the Main Embankment seepage pond into the atmosphere and over and onto the adjacent Crown-owned landscape. It was an innocent, routine documentation, which upon later reflection became significant.

The seepage pond collects and temporarily stores mine waste tailings water that has seeped or been forced through the dam’s pervious embankment material under gravitational force and pressure from the TSF tailings mass, which is then recycled back into the TSF.

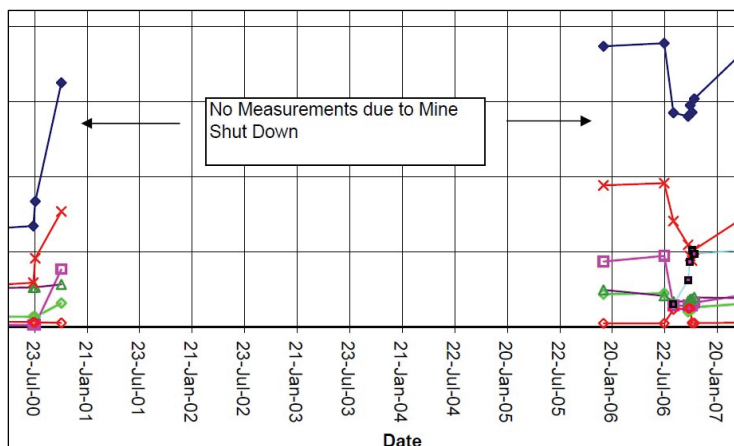
Another disturbing revelation contained in Figures 3.1 (*Foundation Drain Flows*) and 3.2 (*Upstream Toe Drain Flows*) was that for a period of 3 and a half years no measurements of piezometers installed to monitor the foundation drain flows and the upstream toe drain flows were taken from 2001 to 2005, “due to Mine Shut Down”. The document fails to state why those measurements were not taken, or who was responsible for not doing so.

The 2008 TSF inspection report failed to properly contextualize or adequately describe in a devoted section of that report the instrumentation recording oversights and problems which had evidently been accumulating and occurring on Mount Polley's TSF from 2001 through to 2008, as they are only noted in isolated and disjointed sections of the annual report.

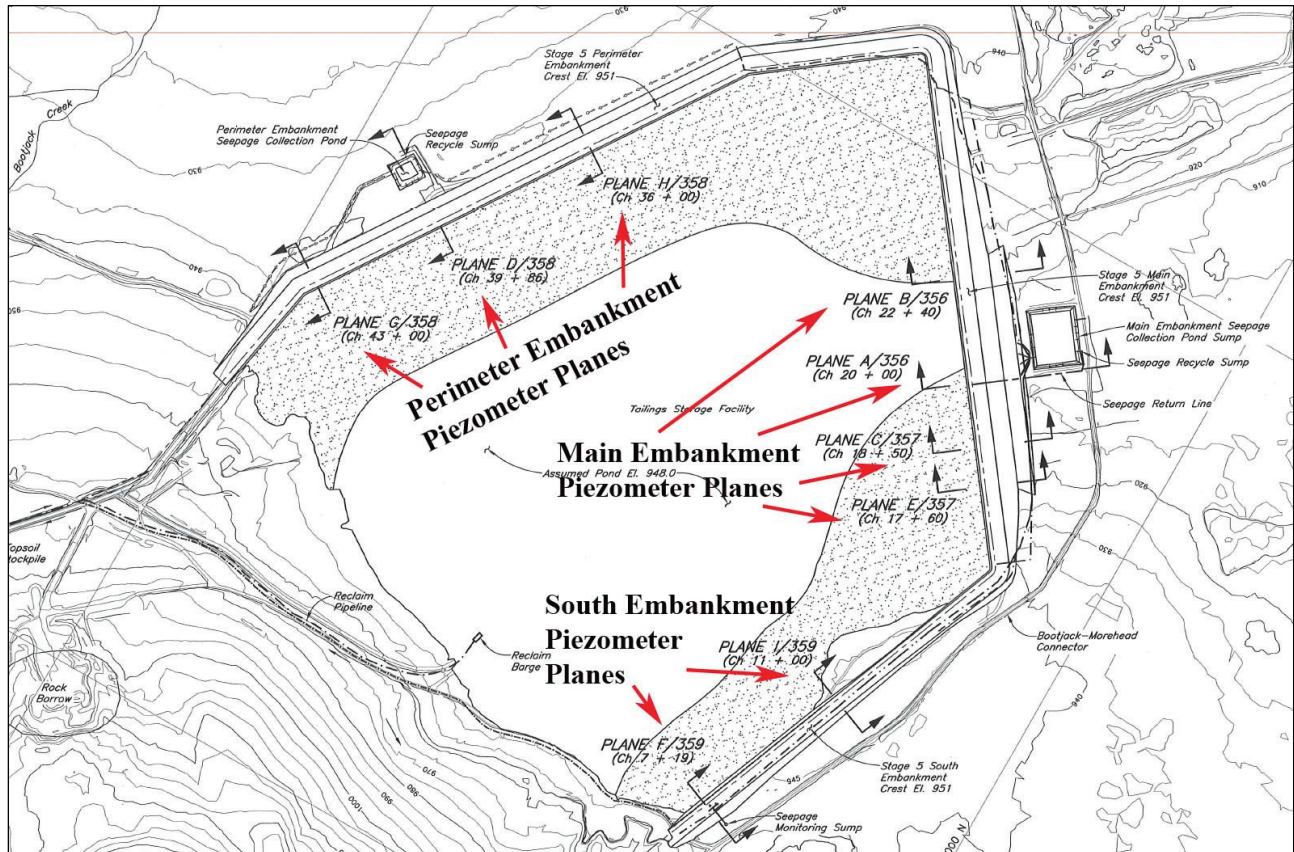
Above: One of the three Planes from the Main Embankment. Unlike the following two drawings, the approximate location of the Phreatic (water table) line is not shown/presented for the Perimeter Embankment. The 2:1 slope for the above drawing appears to be less steep than the actual slope as photographed by the author on September 16, 2014.

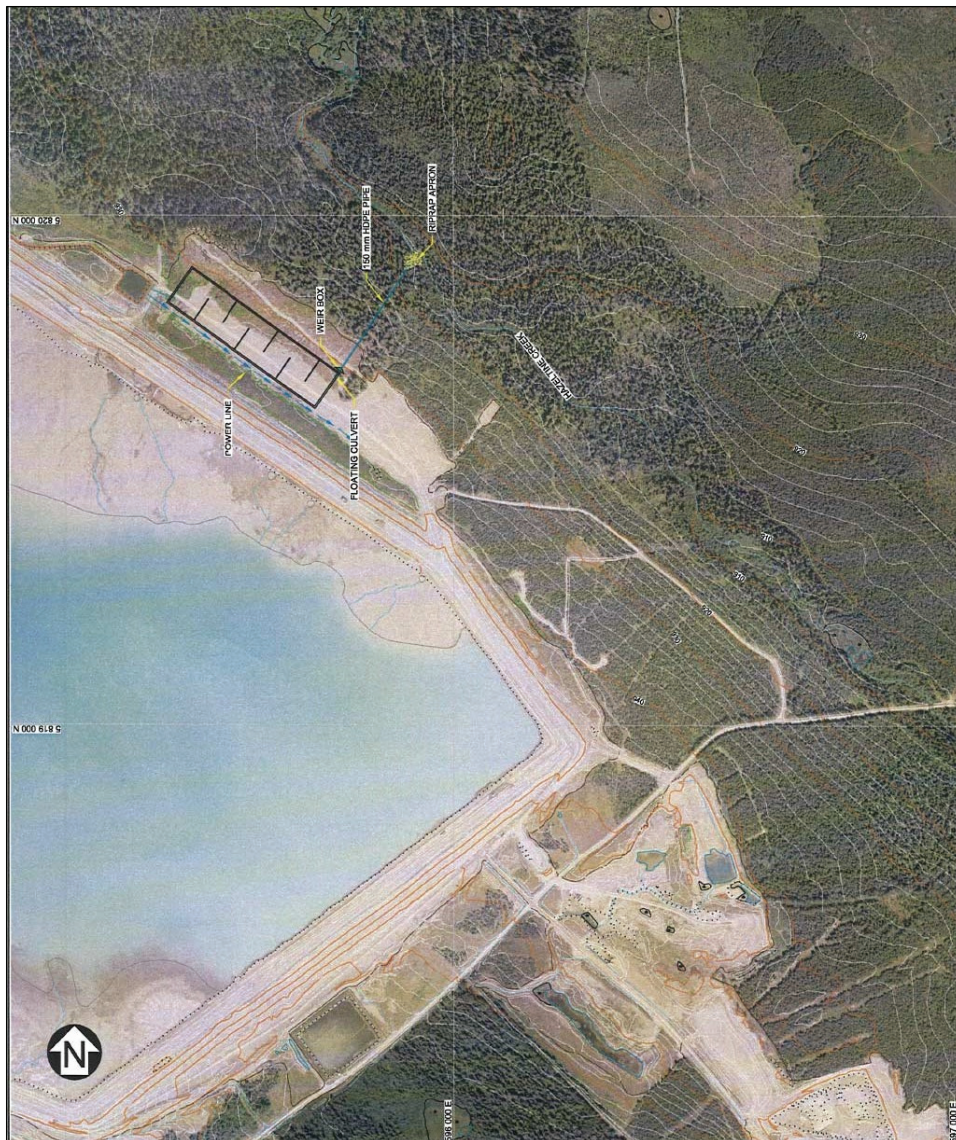
Left: Photo from Figure 1, Sediment / Polishing Pond General Arrangement, in Appendix G, Details of the Proposed Discharge, from the July 2009 Technical Assessment Report for Effluent Permit PE-11678. the image shows the eastern half of the Mount Polley TSF, where the supernatant pond has been pushed up against most of the Main Embankment and against the easternmost section of the Perimeter Embankment. In August 2010, a grader operator noticed a long, thin tension crack along the crest of the eastern extent of the Perimeter Embankment.

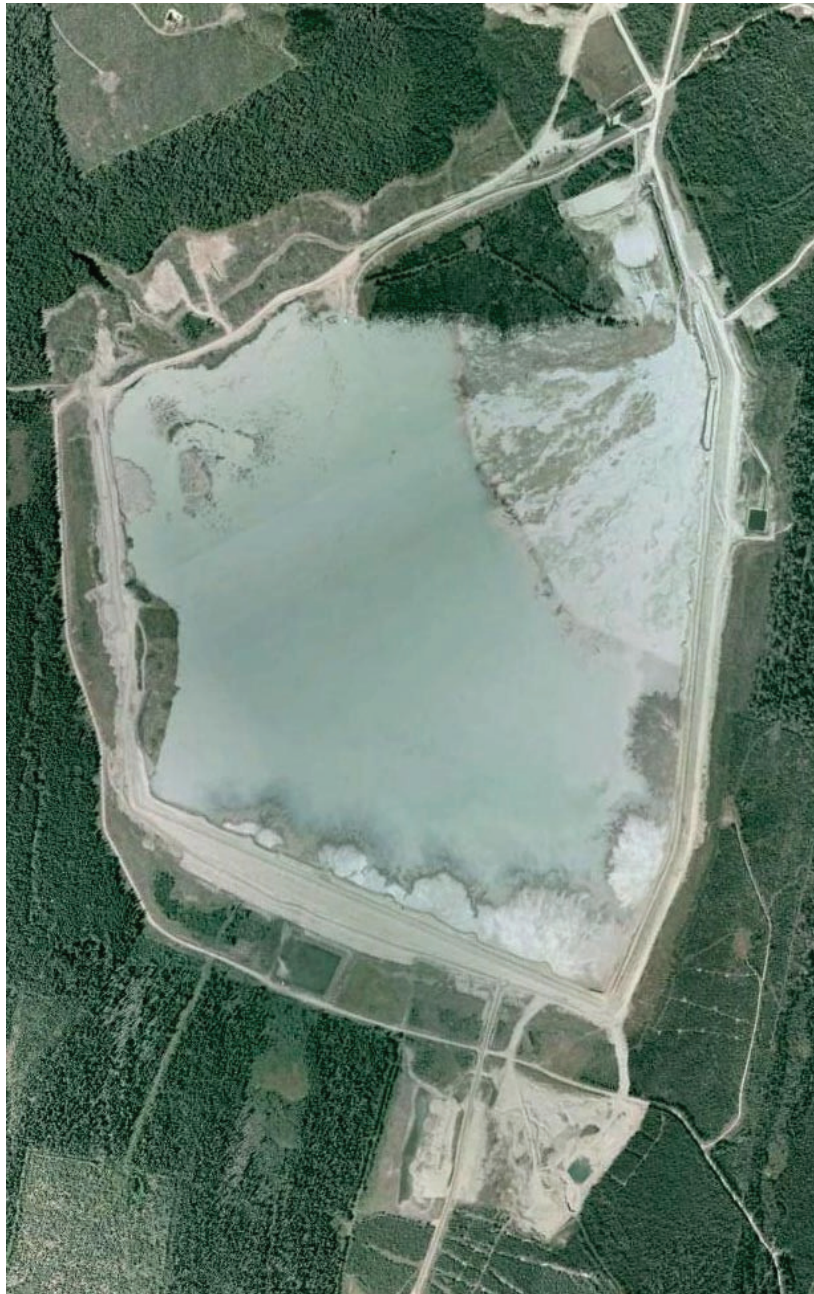
Above: Image of the Mount Polley TSF from Google Earth, snapped by the author on the afternoon of August 5, 2014. The date of the imagery was registered as December 31, 2004. The image was no doubt taken sometime earlier in 2004, during the middle period of the “Care and Maintenance” years. This is MPMC’s abandoned design or configuration state of the supernatant pond during the “Care and Maintenance” years. Note how some of the lands within the TSF were not yet submerged (top area just south of the Perimeter Embankment, and middle left along the South Embankment), as the embankments were at stage 3 raised construction elevation, 945 meters. Note the tailings beach fan developed from the Perimeter Embankment, keeping the supernatant waters pushed diagonally across to the Main Embankment’s southern corner. Note the position of the supernatant pond (for that day), against the lower end of the Main Embankment. (Note: Google Earth has since changed and updated the satellite imagery for Mount Polley area, dated August 9, 2014, for the world to see the tailings disaster imagery.)

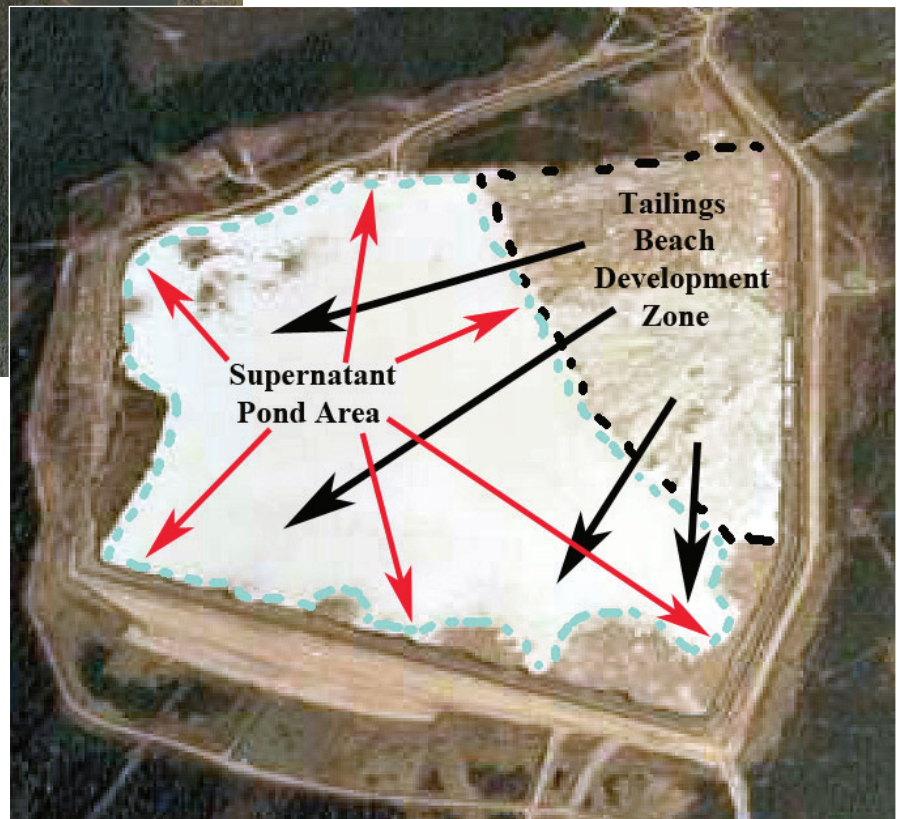
Aerial Photo, October 2005, and cut-out close-up, as shown in Figure 1.1 of Knight Piésold's 2008 TSF inspection report. The concerns about supernatant pond location movement due to concentrated tailings deposition from single-point or uneven spigot discharging from the three Embankments go back to the "Care and Maintenance" years. In October 2005, the crest elevation of the dam was about 951 meters.

The cut-out (right) indicates the problems later stated by AMEC and Knight Piésold about supernatant ponding, here next to all three Embankments, with almost no beaching of tailings.

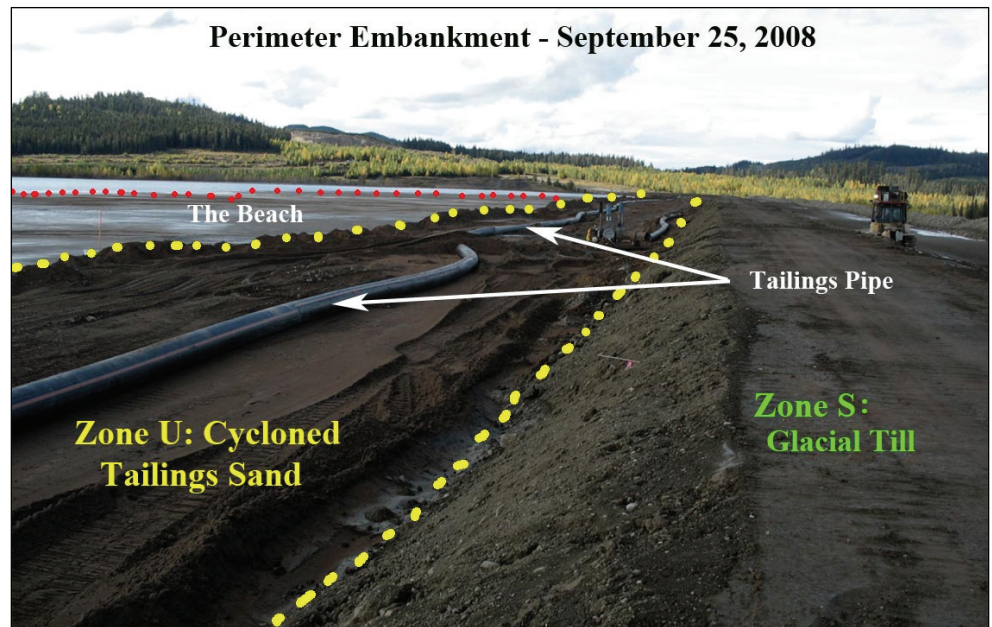
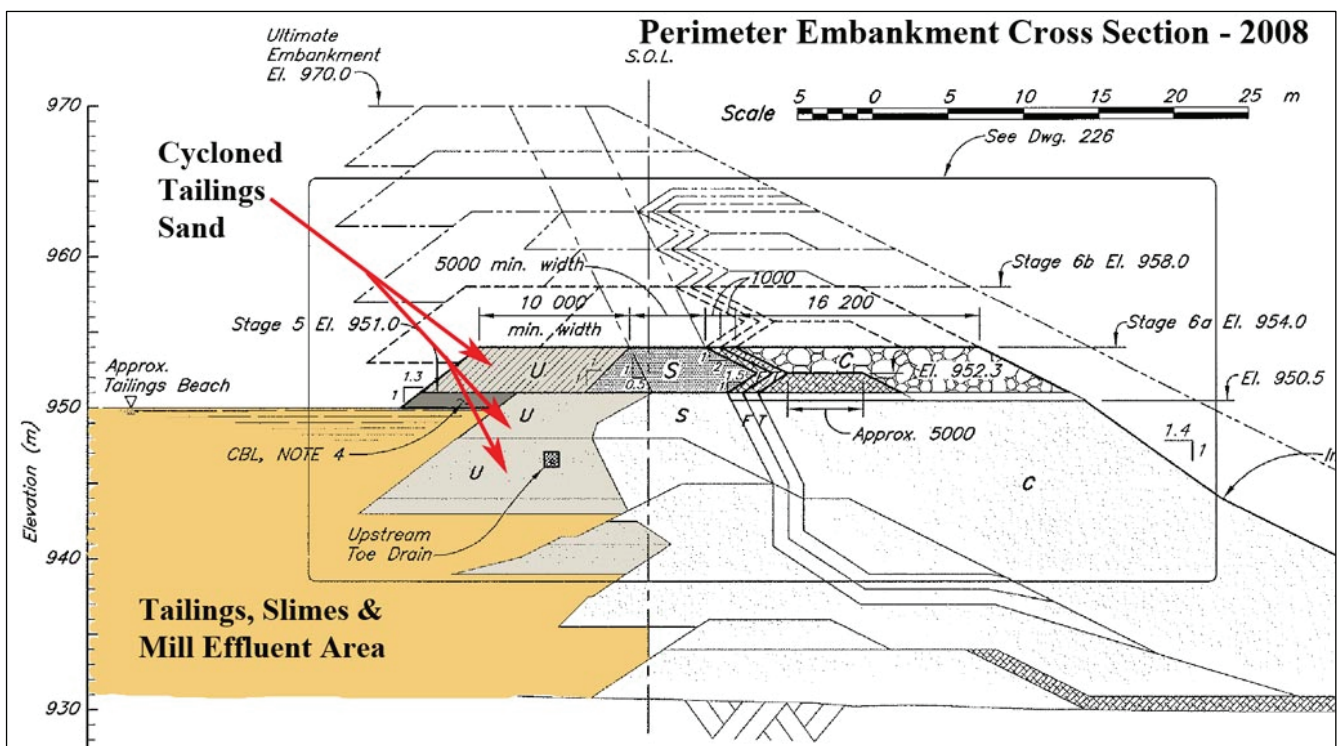
Right: Photo from 2008 TSF inspection report showing construction staging activities on the Perimeter Embankment just south of the August 4, 2014 failure site. The photo shows the Upstream Type design locations for materials, the zones “U” and “S” of which are shown in the drawing below.

Below: drawing No. 225 from the 2008 TSF inspection report shows the Upstream Type design locations for zones “U” and “S” on the Supernatant Pond side, or upstream side, of the Perimeter Embankment.

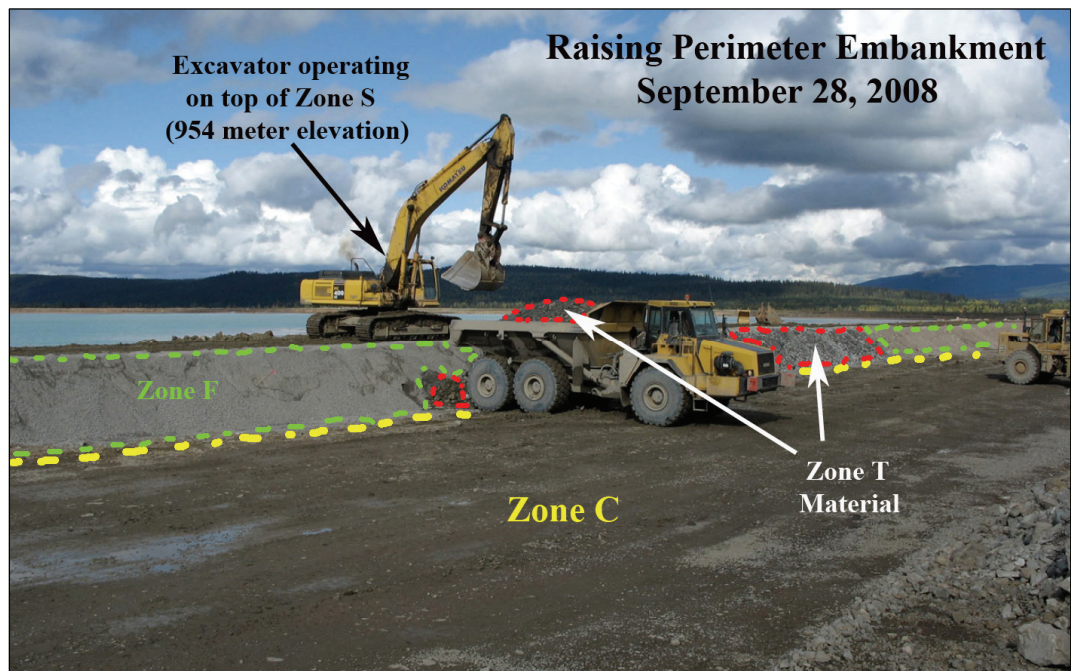
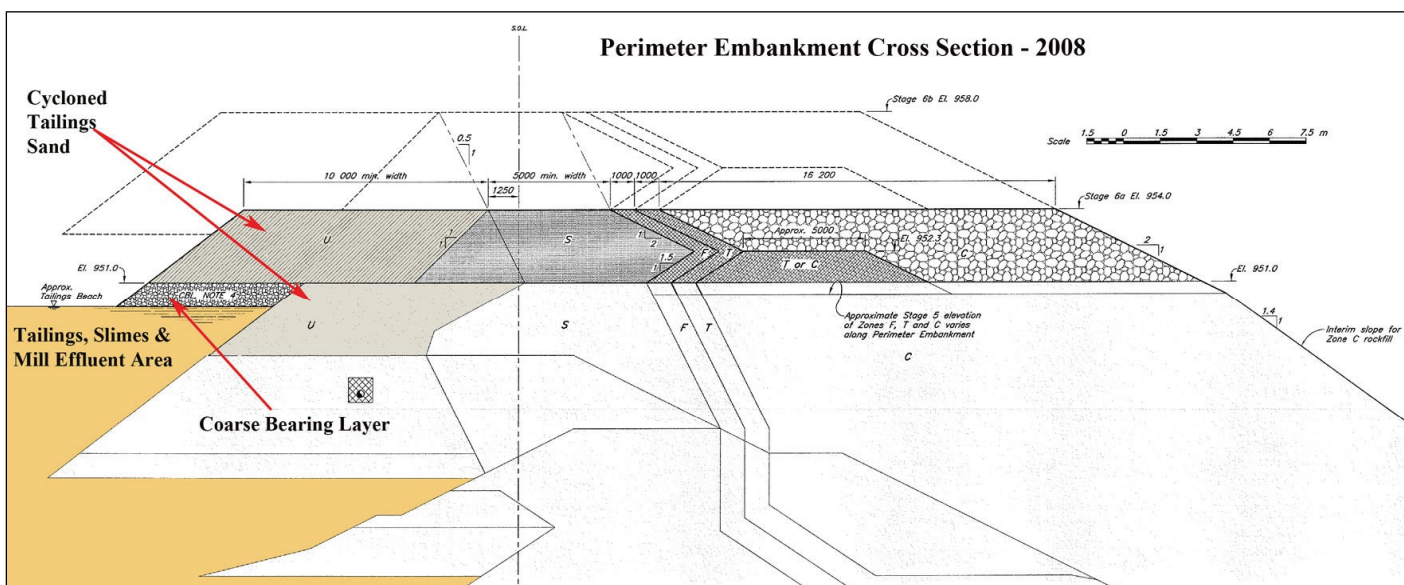
Right: Photo from 2008 TSF inspection report showing construction staging activities on the Perimeter Embankment.

Below: drawing No. 225, Detail A/225, from the 2008 TSF inspection report shows the Upstream Type design locations for zones "U" and "S" on the Supernatant Pond side, or upstream side, of the Perimeter Embankment.

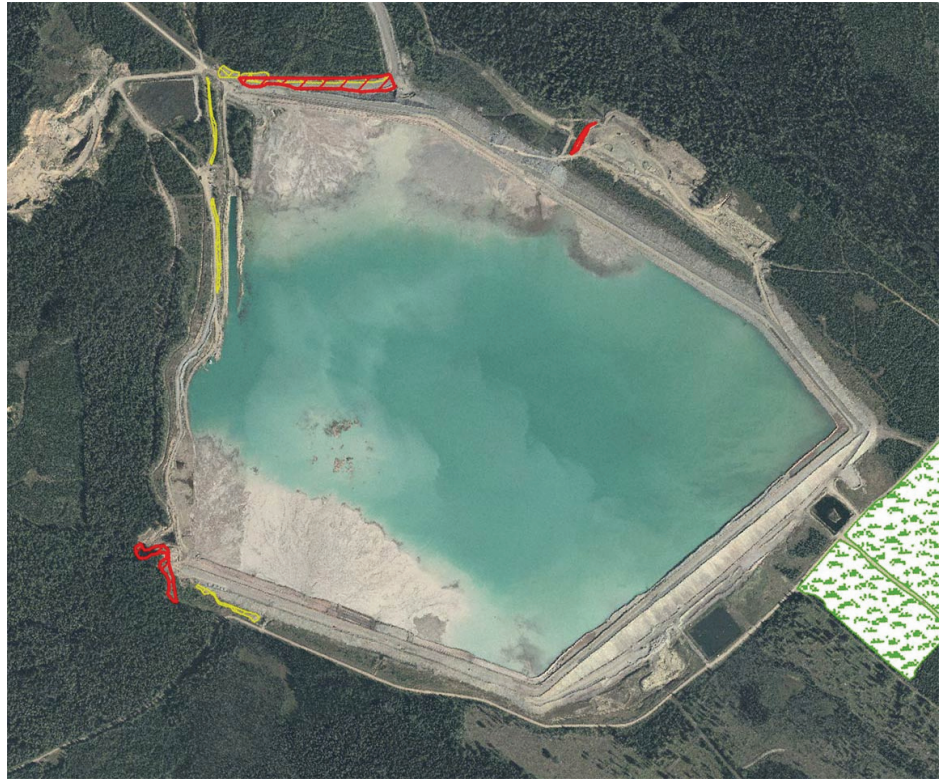
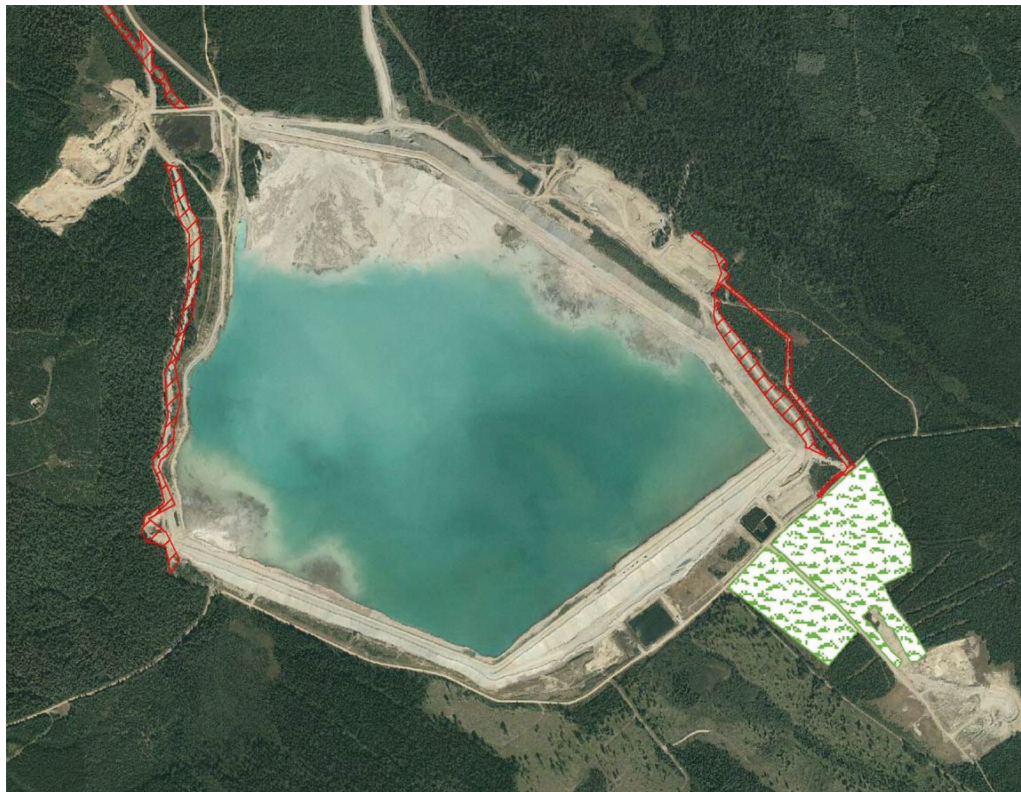
Right: Undated photo of TSF in the 2012 *Annual Environmental & Reclamation* Report.

Below: Undated photo of TSF in the 2013 *Annual Environmental & Reclamation* Report. Note how both undated photo locations of the supernatant waters are in close proximity to the three Embankments.

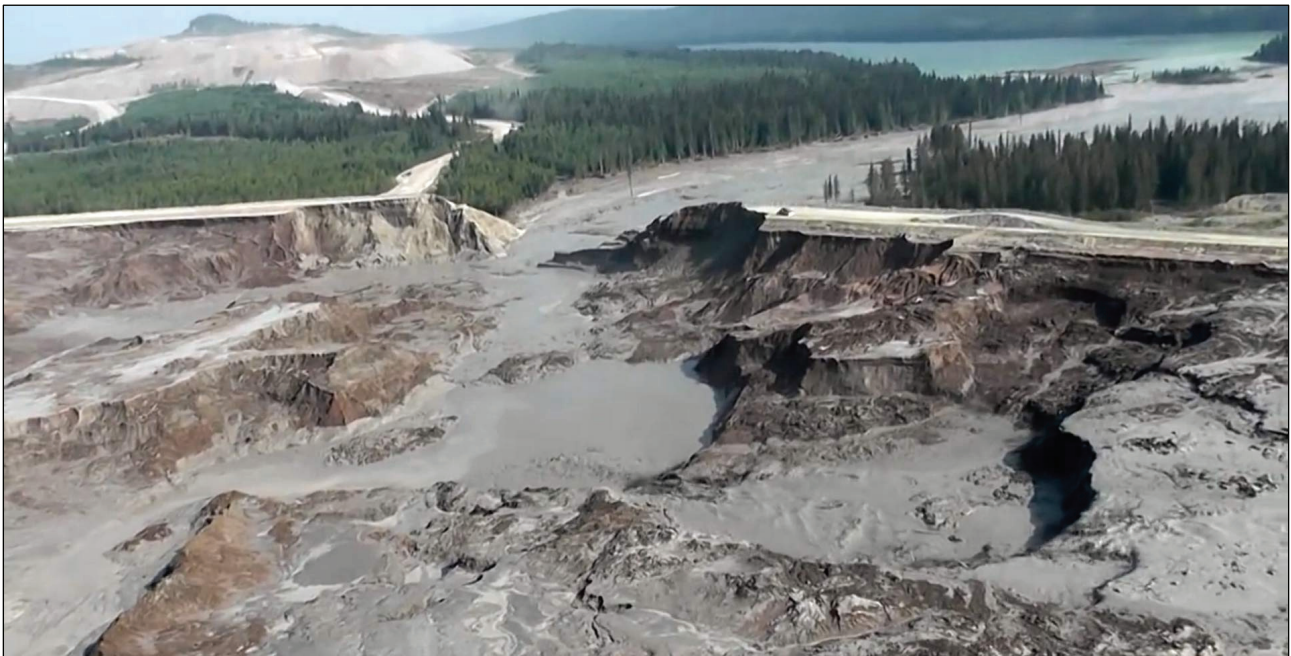
August 4, 2014 image of the Mount Polley Tailings Storage Facility from the helicopter flight showing the breach at the northern end of the Perimeter embankment. The height of the embankment, at the far left of the image, from the road to dam crest, is almost 40 meters. Note the sinkhole/depression at the outer edge of the breach area and remaining slump of embankment material located just above the sinkhole area. After initial burst flows of water and tailings began to subside from the tailings mass to the far right of the image, cascading, draining flows then began to unravel from the center area of the image. According to company records, the total area of the Tailings Facility is about 235 hectares.

August 4, 2014 image from the helicopter flight.

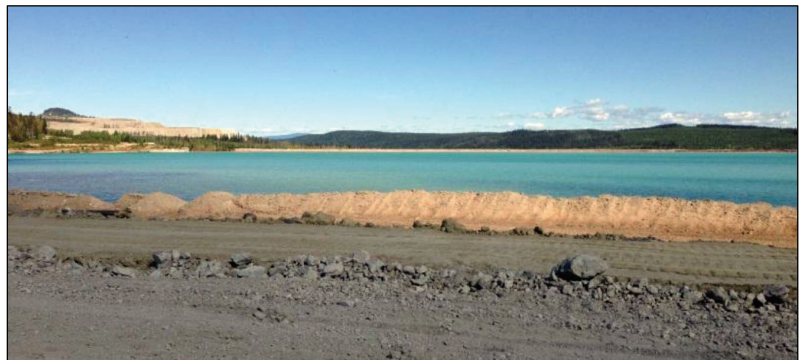
Cover photo from SRK Consulting's Appendix O, Mount Polley Water and Load Balance. The Mount Polley TSF shows no beach development in this photo, which was taken from the South Embankment, looking northward to the Perimeter Embankment.

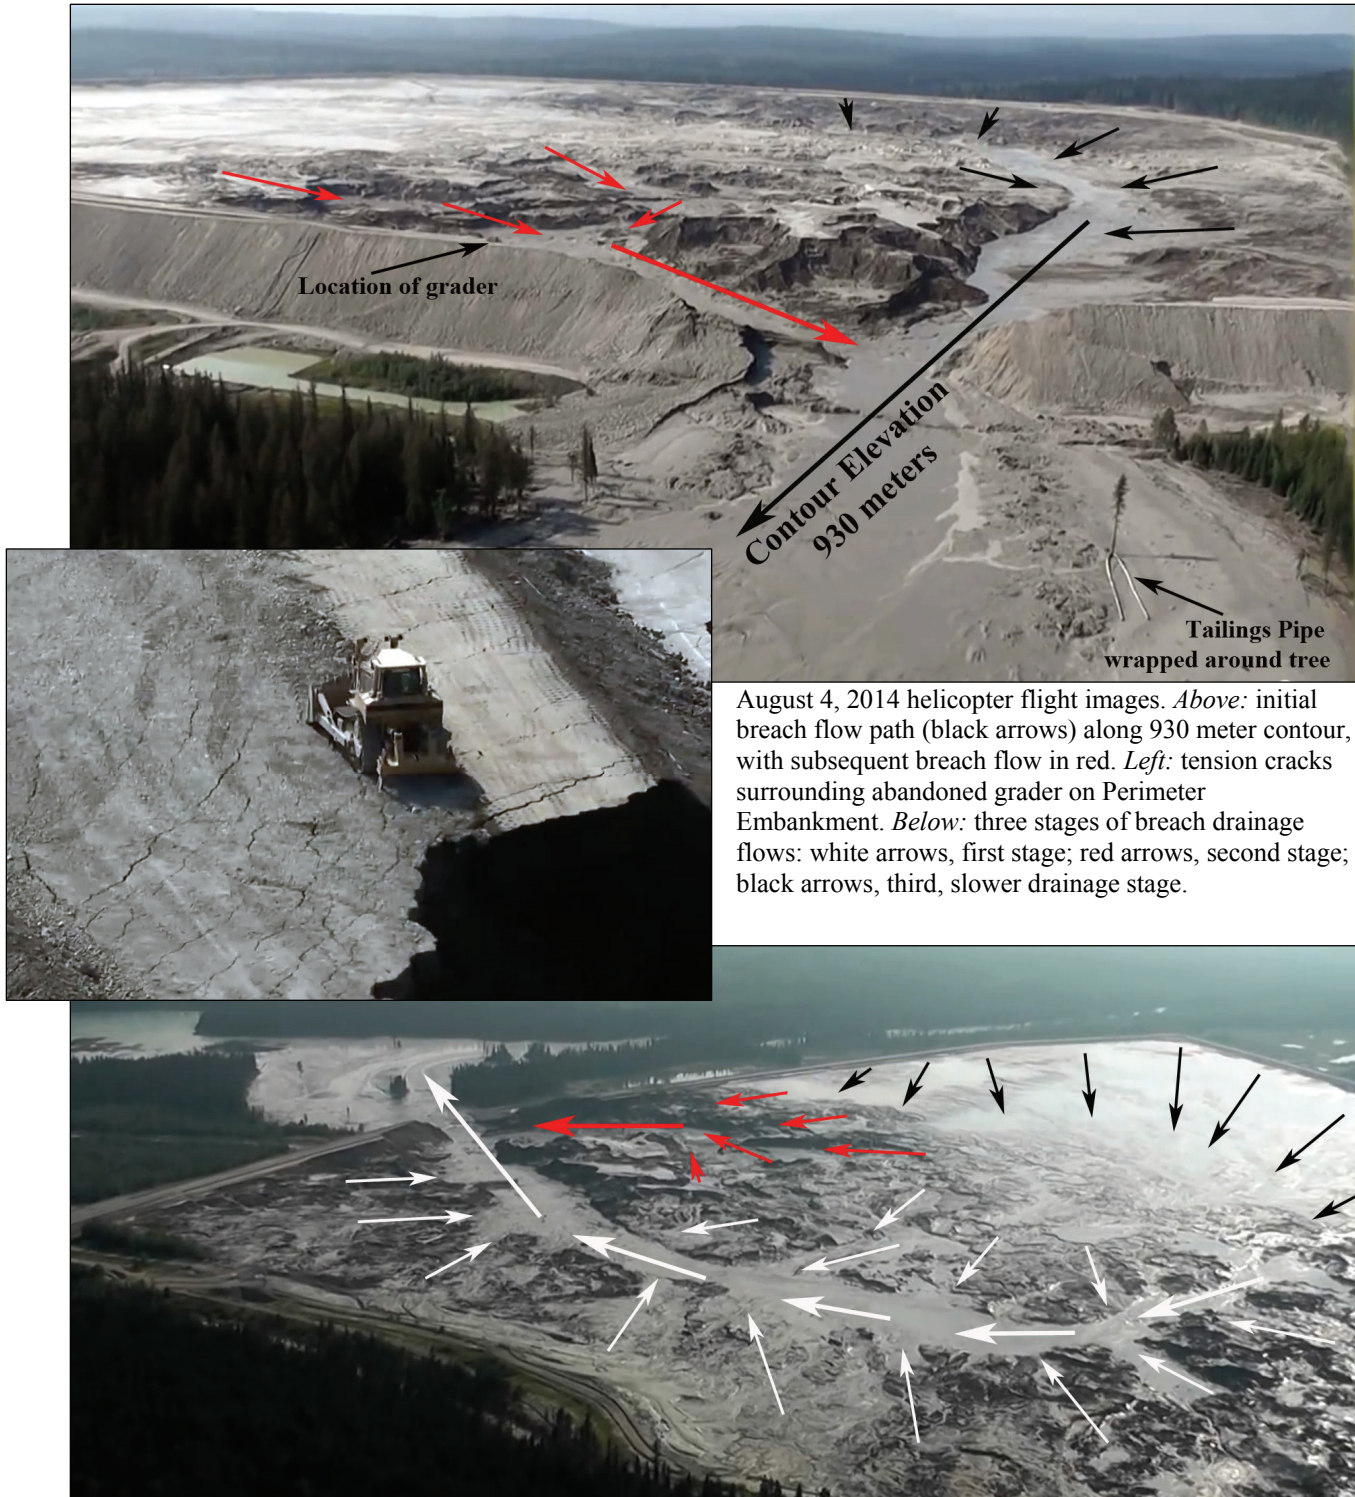
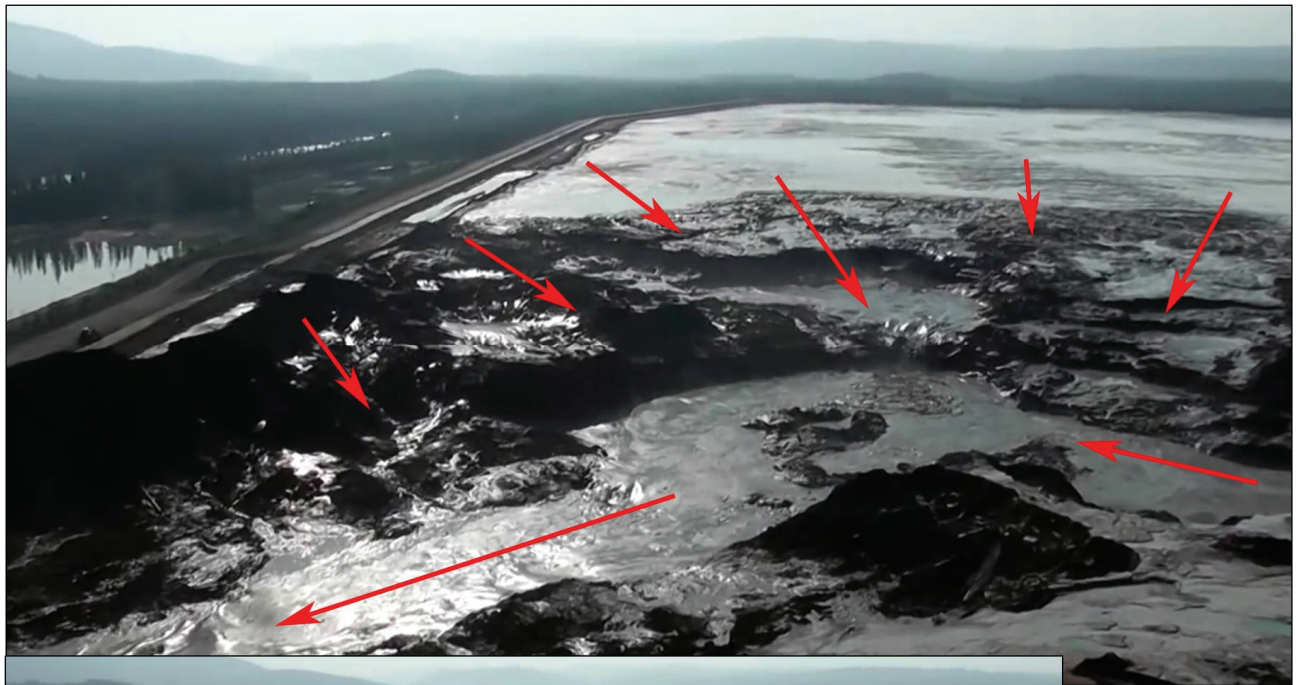
Serious Dam Integrity Issues

Amongst Imperial Metals Corporation's ominous self-inflicted misfortunes, embarrassingly pressing follow-up duties, and menacing multiple liabilities following the tailings catastrophe of August 4, 2014, is a rather serious health and safety state issue of its severely wounded Tailings Storage Facility. Namely, that the integrity of the TSF as a safe containment for tailings to last in perpetuity is in dire question. And, to address that tricky question would require substantial capital and extra heavy duty equipment to adequately reinforce the entire outer embankment structures.
