British Columbia's Mount Polley copper/gold/silver mine waste tailings disaster of August 4, 2014, located near the western-most reach of Quesnel Lake, is among the largest recorded disasters, by volume, in world history, with updated estimates of about 25 million cubic meters of toxic waters and heavy metal mine waste contaminants having escaped into the nearby environments of Hazeltine Creek and Quesnel Lake, destroying and inundating everything in its path, a most terrible and preventable tragedy.

This is the first investigative report on Mount Polley since the date of the disaster, 17 weeks previous, and provides an assessment and introductory history behind the inner workings of a terrible tragedy, of what appears to be an environmental crime. And, it is published during a time of interim darkness, as the BC government is temporarily withholding report and related information not already released concerning the planning and operations of the Mount Polley mine, perhaps until the early months of 2015 or later. That is when the reporting of one of a few separate investigations is scheduled for public release: a government-appointed three-panel member review committee (under narr

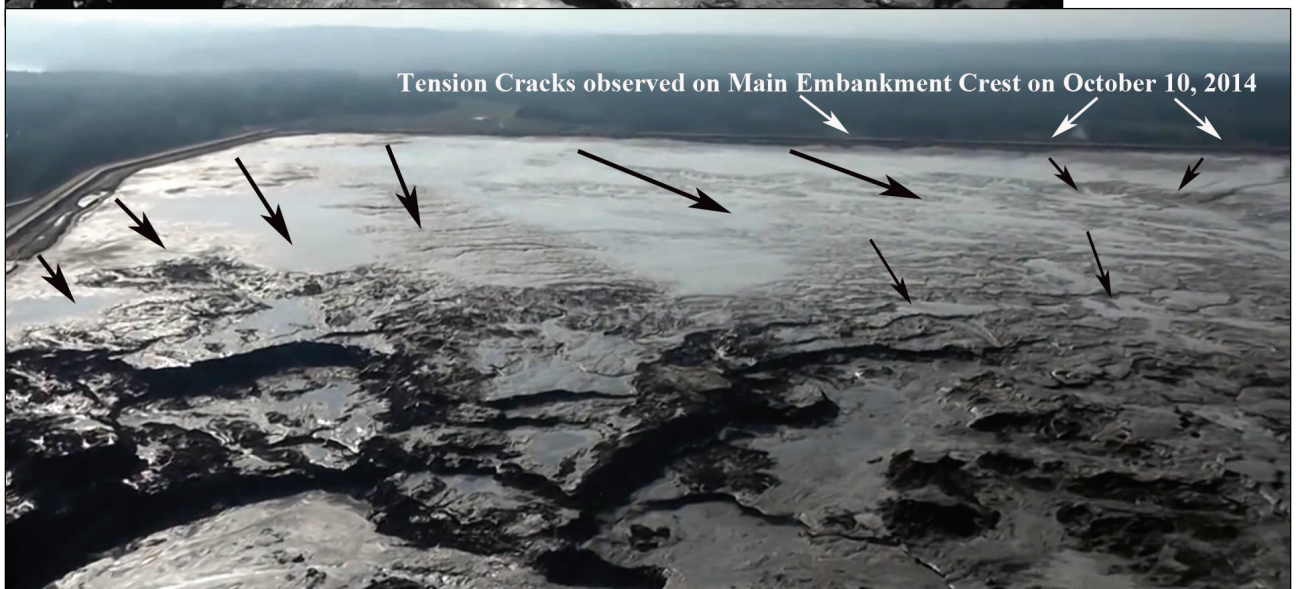
Images from August 4, 2014 helicopter flight. They show the state of the disaster about 5 hours after the breach occurred, during the second phase of draining, cascading physical collapsing of the saturated tailings mass, the forces of which affected the integrity of the 3 embankments.

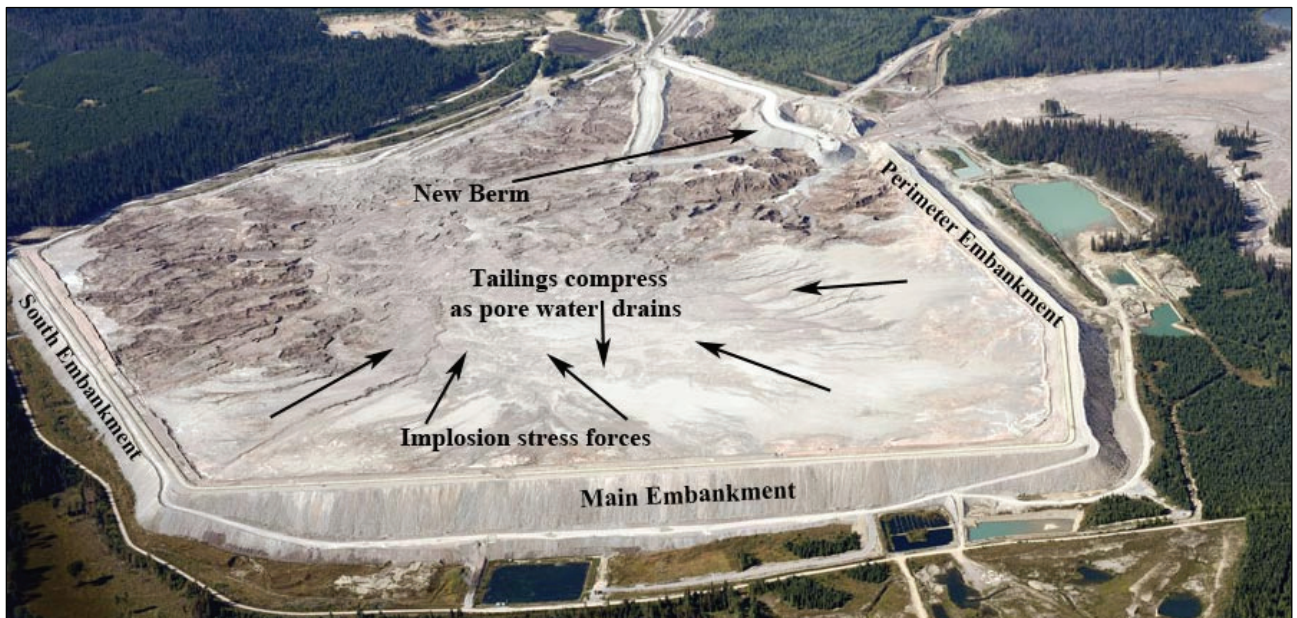
Below: Recent oblique photo of the Mount Polley TSF by Terrasaurus, used here to show the lateral and downward stress forces from retreating and drained interstitial / pore waters.

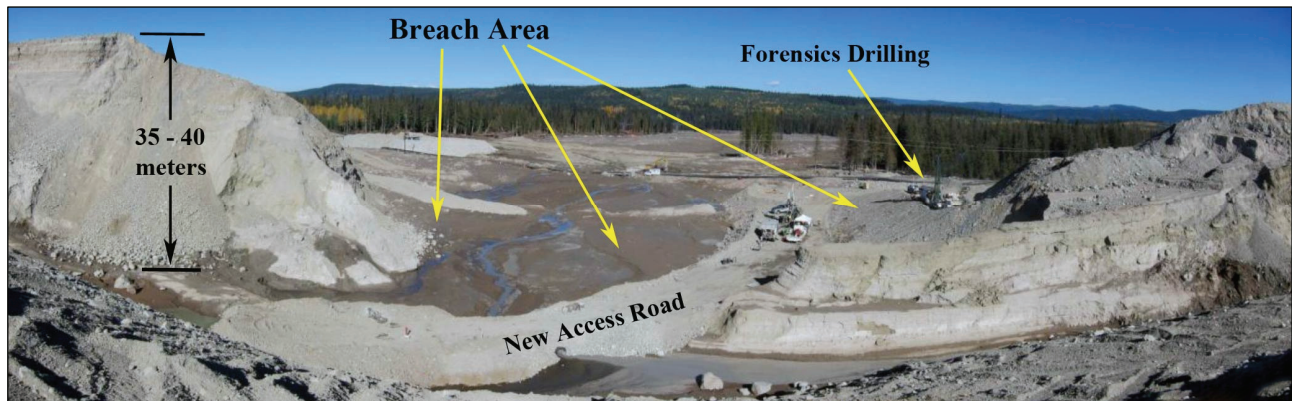
Through originating orders by BC's Chief Inspector of Mines sometime in September 2014, a "forensics drilling" investigation began of the breach site, located at the northwest sector of the Perimeter Embankment. After initial road access was constructed on the eastern downstream side of the breach gap area and towards the centre of the breach area, the drilling equipment set out to determine, through numerous core samplings that are presently being assessed, if the foundation material of the Perimeter Embankment may or may not have been the root cause of the tailings disaster.
