**Watershed Assessment of Proposed Forest Development  
within the  
Peachland Creek Community Watershed**

**Revised Final Report**

**November 5, 2018**

**Rob Scherer, Ph.D., P.Eng.  
Forest Hydrology Consulting  
Kelowna, BC**

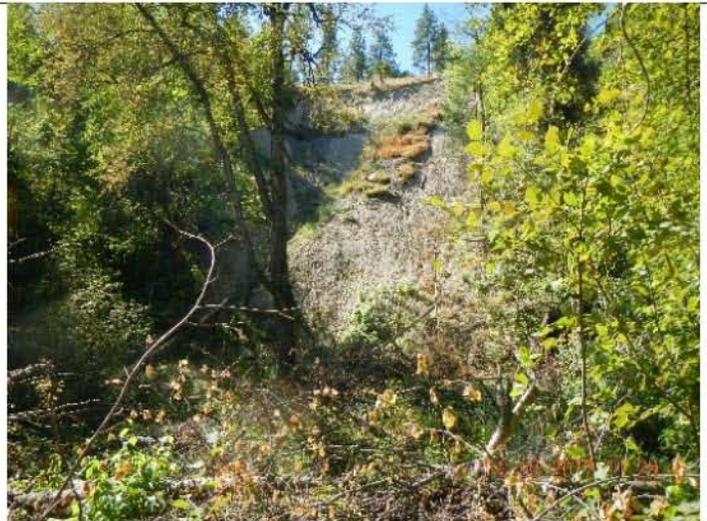
**Photo #6 (Field Stop #3):**

- Field Stop #3 (Photo 4 to 8) – Peachland Creek situated adjacent to the Munro FSR and downstream to the District of Peachland water intake were impacted by a landslide that occurred below the Munro FSR on April 28, 2017. The landslide event resulted in a large pulse of sediment moving down the channel into the District of Peachland’s settling ponds. In May 2017 approximately 120 m of channel was relocated to the eastern side of the channel valley to avoid further undercutting by Peachland Creek at the toe of the unstable slope and to minimize sediment deposition from upslope into the creek (D. Dobson, personal communication, November 7, 2017).

Landslide directly impacted Peachland Creek subsequent to this event ~120 m of Peachland Creek was relocated to the eastside of the partially confined channel valley.

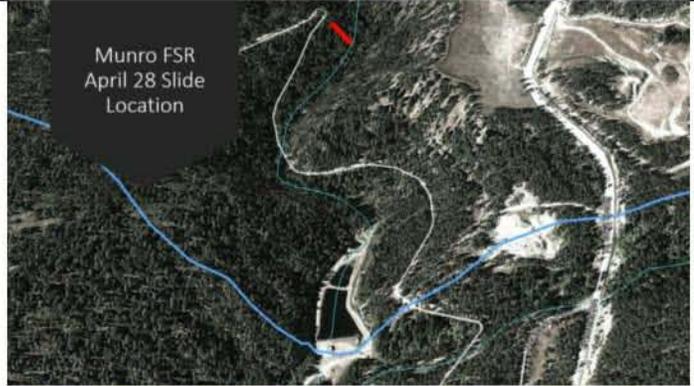
**Photo #7 (Field Stop #3):**

Overview of Munro FSR landslide (red arrow) situated above the District of Peachland water intake.

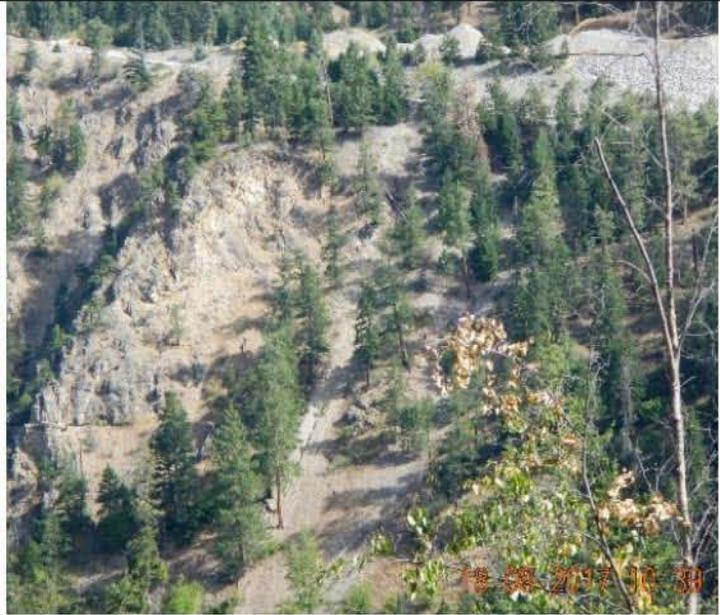
Overland flow along road surface and associated surface erosion from Brenda Mines Road directly connected to Peachland Creek as evidenced by rill erosion (Relatively large rill shown in centre of photo). Note: Rill erosion is also visible on Google Earth images.

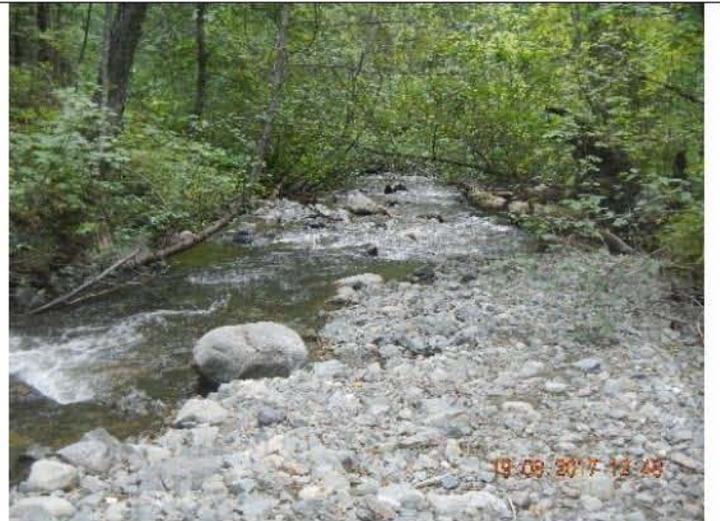
**Photo #17 (Field Stop #8):**

Stable, Cascade-Pool (Boulder/Cobble) channel

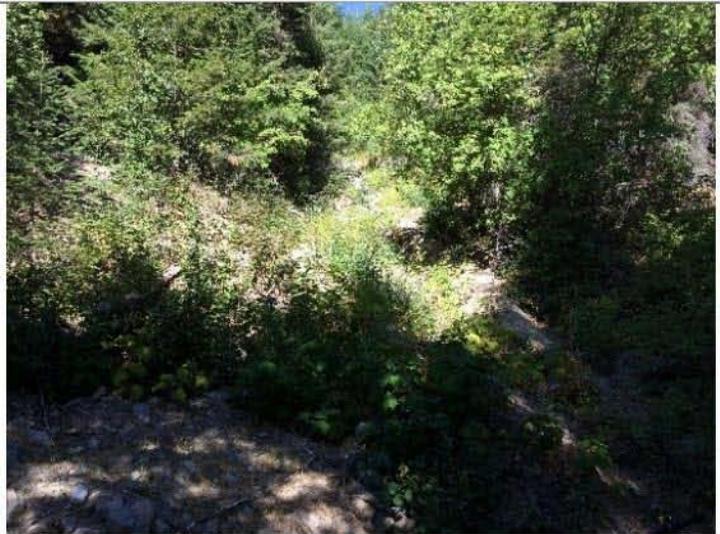
Debris flow track is partially vegetated and sediment fence has been used to contain sand/gravel.

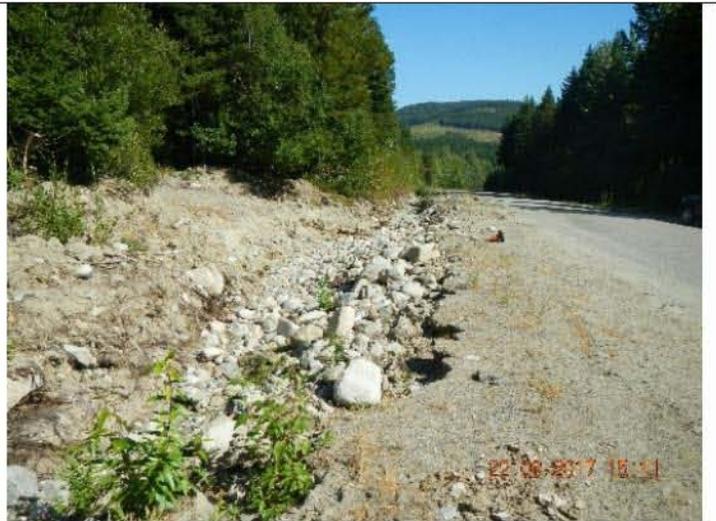
Culvert inlet is plugged at the Brenda Mines Road crossing over Mile Creek. A pond above the road overtopped and eroded the ditchline for >400 m down Brenda Mines Road. Road ditchline was repaired in the summer of 2017 after this photo was taken.

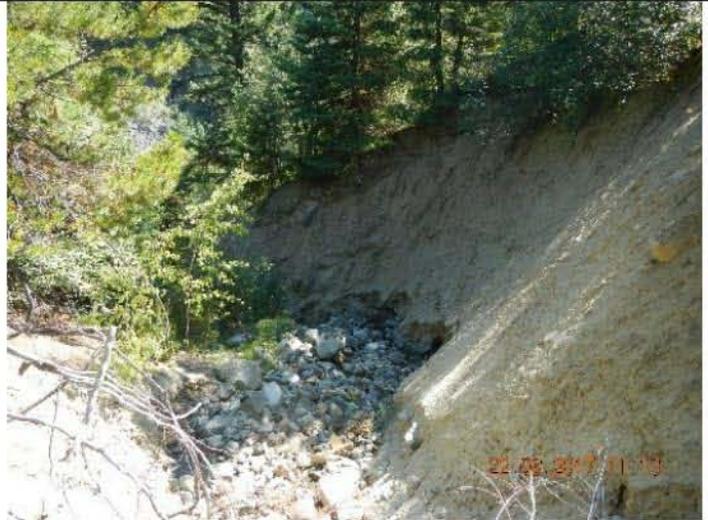
East end of diversion ditch from Peachland Lake drains onto steep valley slope. A large gully has been eroded in the steep valley slope as result of flow from diversion ditch.

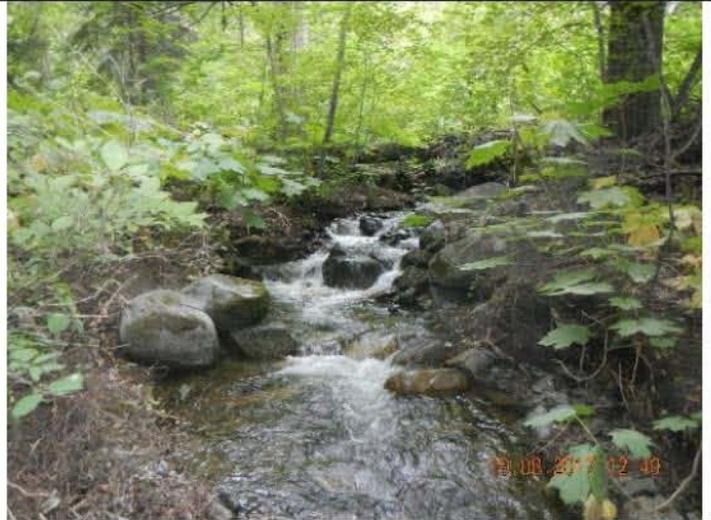
Partially Degraded, Step-Pool (Cobble) channel. Moderate to low bank erosion. Exposed fine roots along banks. Channel overtopped bankfull in the spring of 2017.

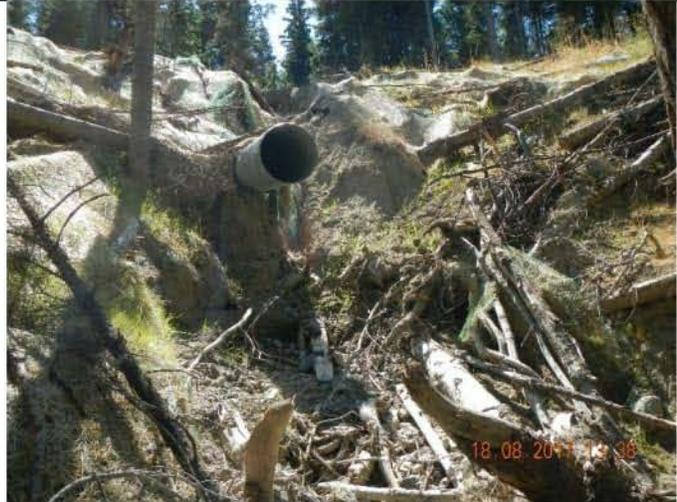
Small failure above and below crossing. Highly erodible sandy silts. Fine sediment delivery is directly connected to Greata Creek.

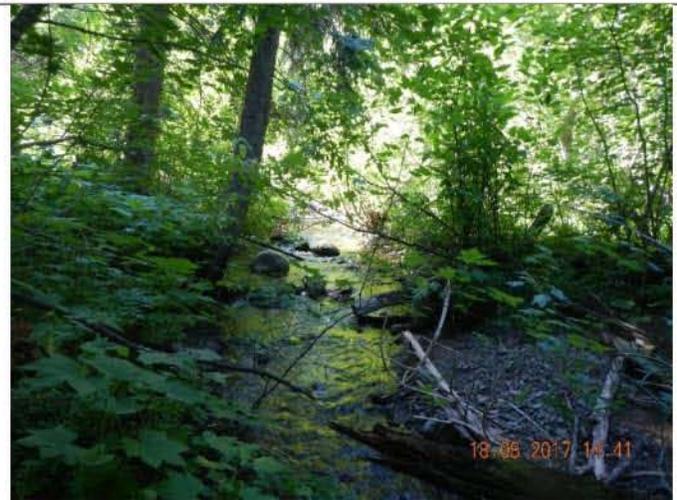
**Photo #45 (Field Stop #51):**

Stable, Riffle-Pool (Cobble) channel.

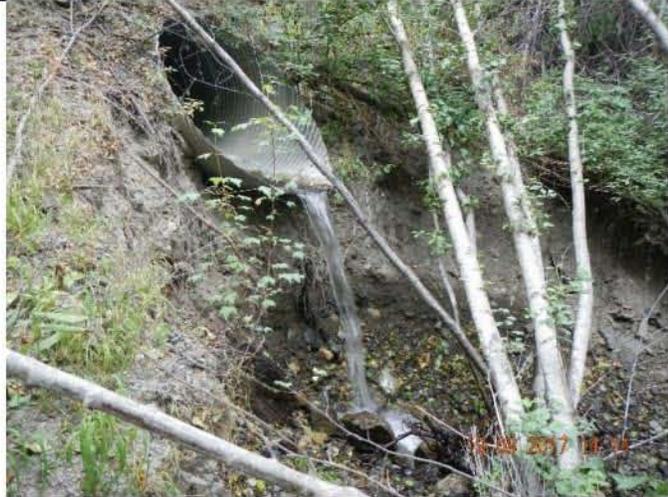
Moderately Aggraded, Riffle-Pool (Gravel) channel above road crossing. Moderately Degraded, Cascade-Pool (Boulder/Cobble) below road crossing.

Excessive erosion of channel below culvert (gun barrel culvert protruding from road fill). Surface flow over Peachland Main is entering Bolivar Creek on the uphill side of the road. A relatively large wedge of fine sediment was observed above the culvert inlet.

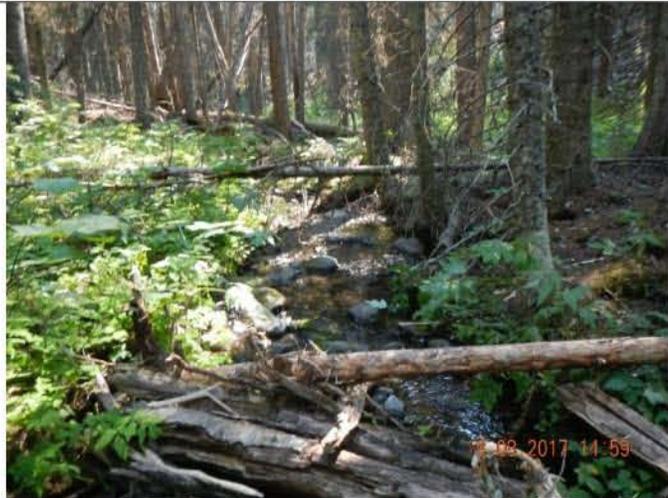
**Photo #48 (Field Stop #56):**

Stable, Cascade-Pool (Cobble) channel. 30 m reserve left along creek with limited evidence of bank erosion from the 2017 spring freshet

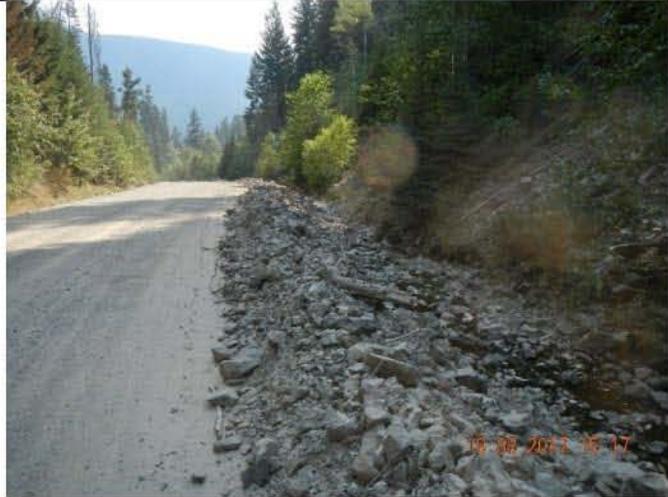
Moderately Degraded, Step-Pool (Boulder/Cobble) channel. Bolingbroke Creek eroded Peachland Main in the spring of 2017. The channel was subsequently excavated to maintain flow down ditchline.

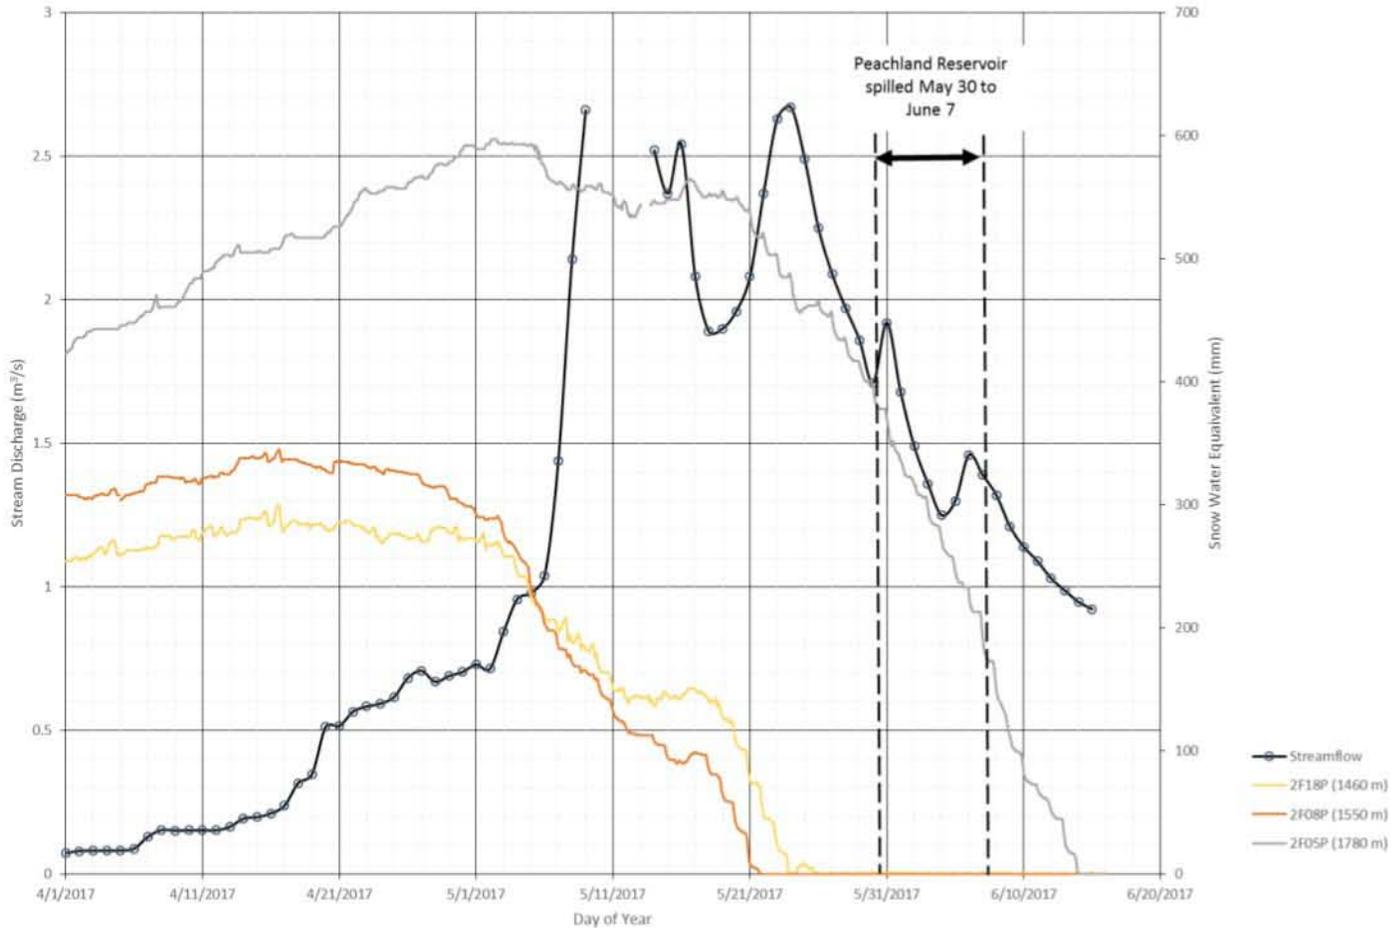
It should also be noted that during the spring of 2017 streamflows on Greata Creek peaked approximately 6-9 days prior to filling of the Peachland Lake reservoir (refer to Appendix D). This indicates that in the spring of 2017 the large peak flow generated from mid-elevation snowmelt

**Figure D.1.** Greata Creek streamflow data (Stn #08NM173) from April 1, 2017 to June 20, 2017. Peak flow on May 12, 2017 and on May 24, 2017 exceeded a one in 50 year event. Also shown is automated snow survey data from various elevations within the Okanagan Basin (Brenda Mines (2F18P), Greyback Reservoir (2F08P), Mission Creek (2F05P)). The dates at which the Peachland Lake reservoir spilled are also shown. Note: In 2017 stream discharge data is missing for May 10 to May 13, 2017 therefore the annual maximum peak flow in 2017 likely exceeded the actual recorded maximum peak of  $2.67 \text{ m}^3/\text{s}$ .

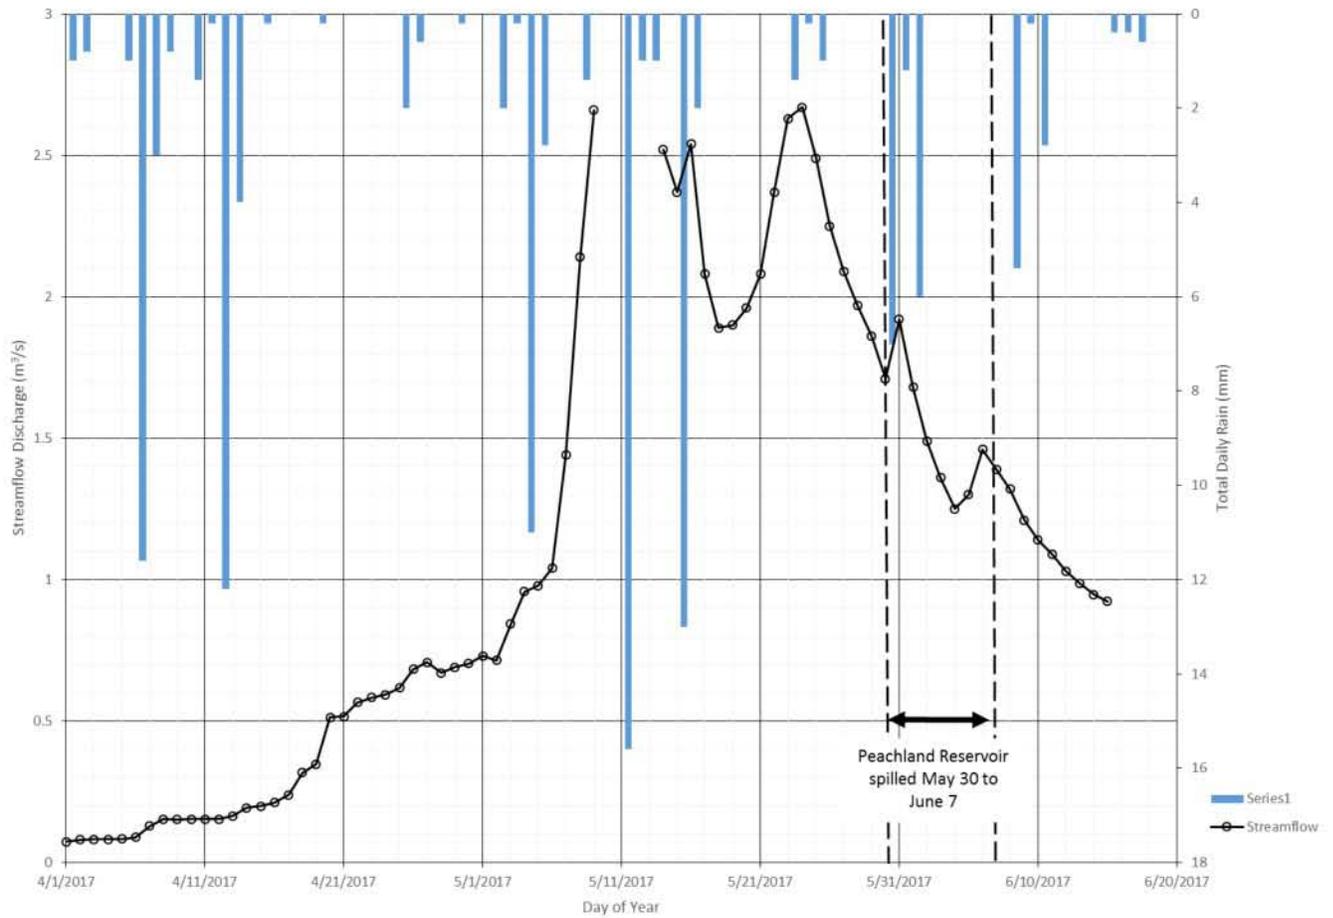
**Figure D.2.** Greata Creek streamflow data (Stn #08NM173) from April 1, 2017 to June 20, 2017. Peak flow on May 12, 2017 and on May 24, 2017 exceeded a one in 50 year event. Also shown is rainfall data from the Peachland Environment Canada weather station (Climate ID #1126070). The dates at which the Peachland Lake reservoir spilled are also shown. Peak flows in Greata Creek were primarily related to mid-elevation (1300 m to 1500 m) snowmelt and rainfall.

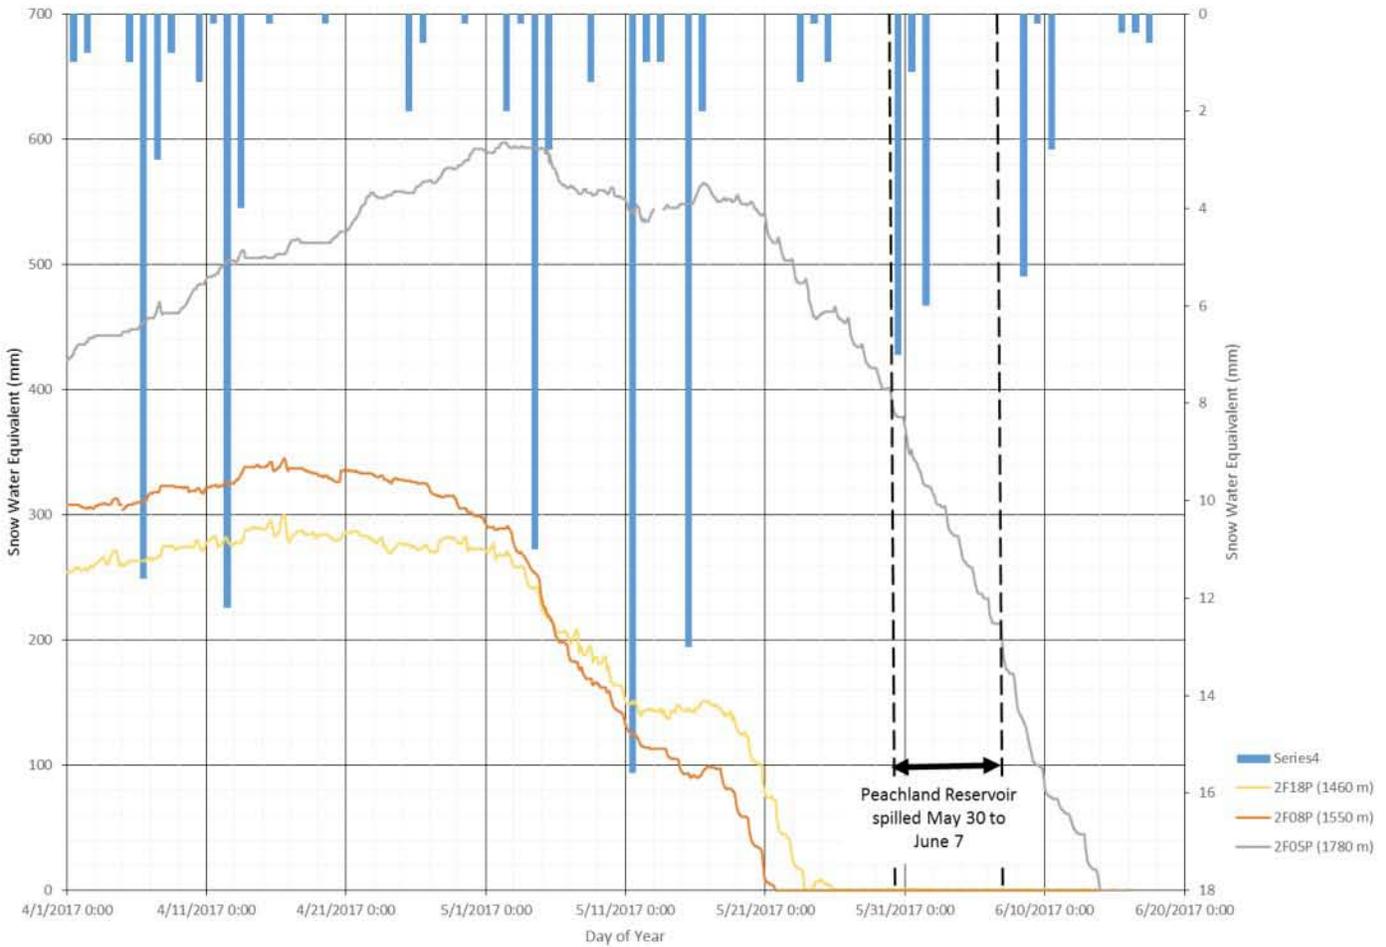
**Figure D.3.** Automated snow survey data from various elevations within the Okanagan Basin (Brenda Mines (2F18P), Greyback Reservoir (2F08P), Mission Creek (2F05P)) are shown. Also shown is rainfall data from the Peachland Environment Canada weather station (Climate ID #1126070). The dates at which the Peachland Lake reservoir spilled are also shown. Peak flows in Greata Creek were primarily related to mid-elevation (1300 m to 1500 m) snowmelt and rainfall.

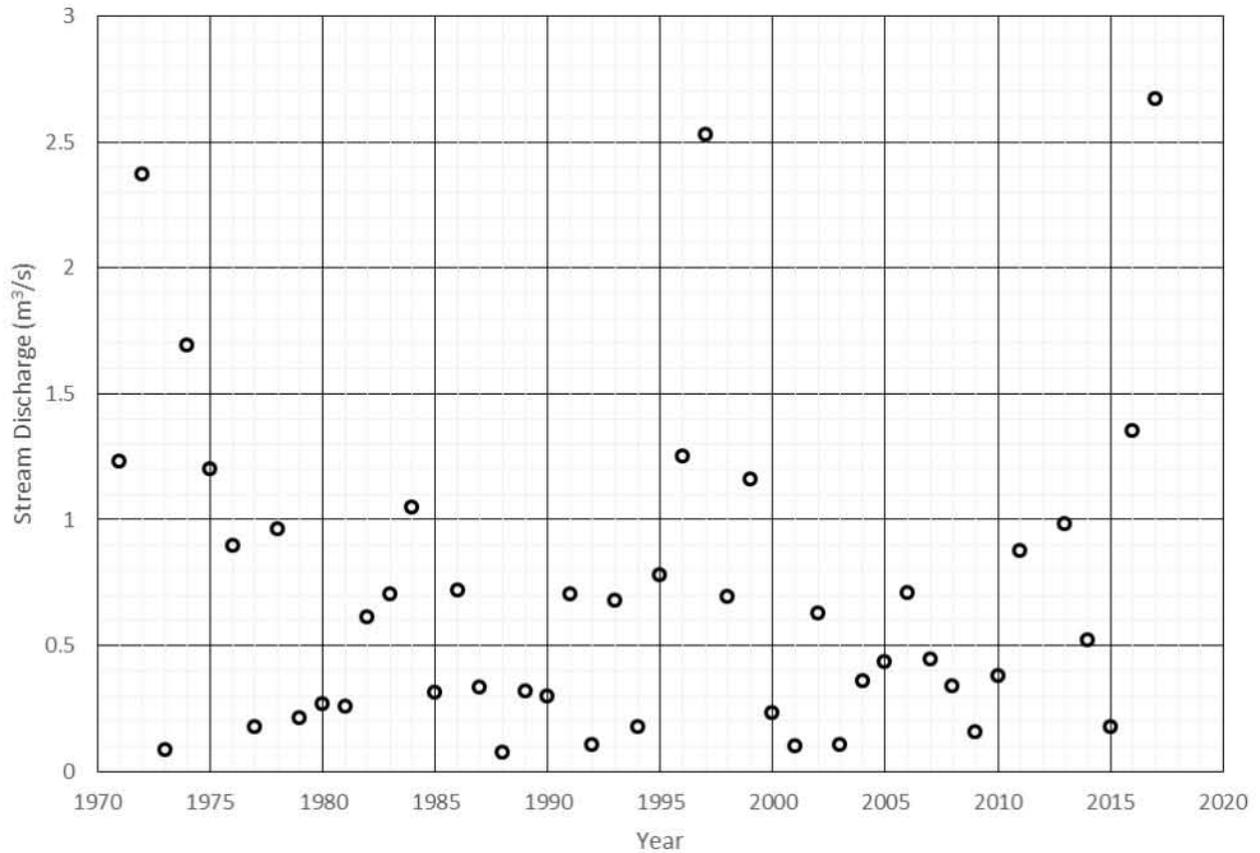
**Figure D.4.** Annual peak stream discharge for Greata Creek (Stn #08NM173) from 1971 to 2017. Note the three largest annual peak flows on record occurred in 2017, 1997 and 1972. Note: In 2017 stream discharge data is missing for May 10 to May 13, 2017 therefore the annual maximum peak flow in 2017 likely exceeded the actual recorded maximum peak of 2.67 m<sup>3</sup>/s.
